Laboratory Testing of Handpumps for Developing Countries,
World Bank Technical Paper #19 from the Rural Water
Supply Handpumps Project

Rural Water Supply Handpumps Project

Laboratory Testing of Handpumps for Developing Countries: Final Technical Report

Consumers' Association Testing and Research Laboratories

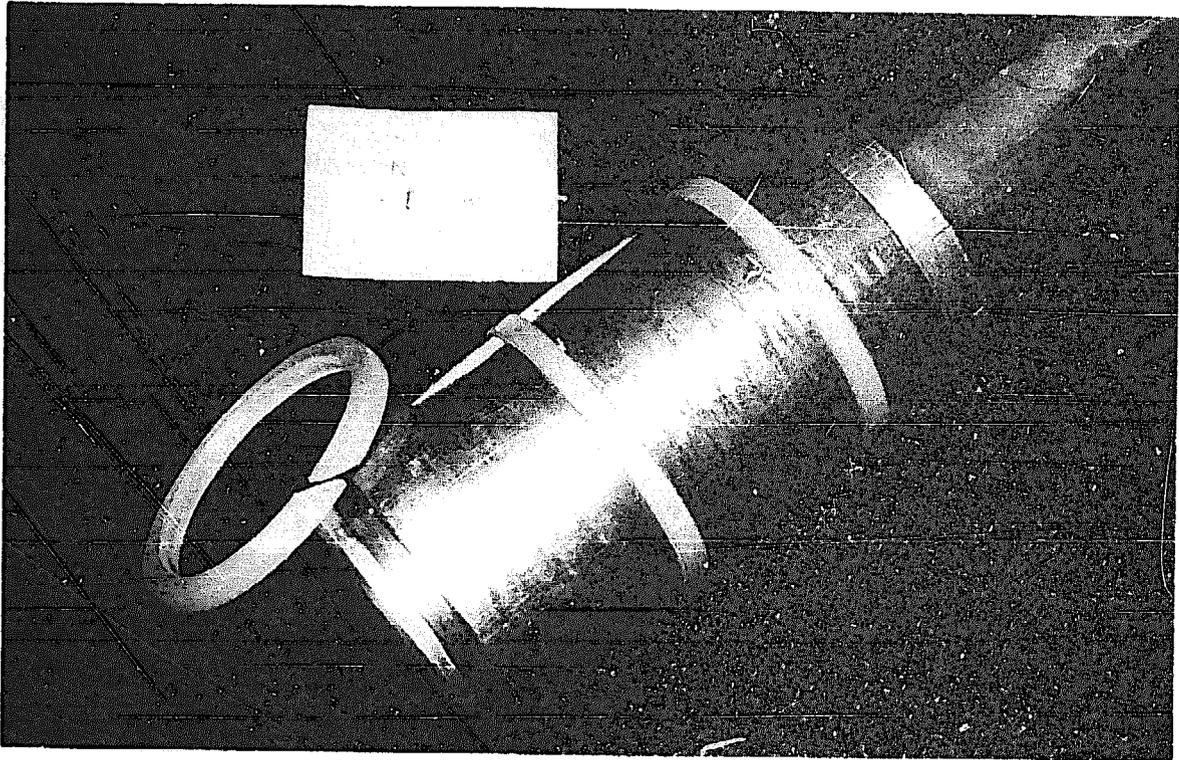
Polyethylene seals made to replace the original leather seals

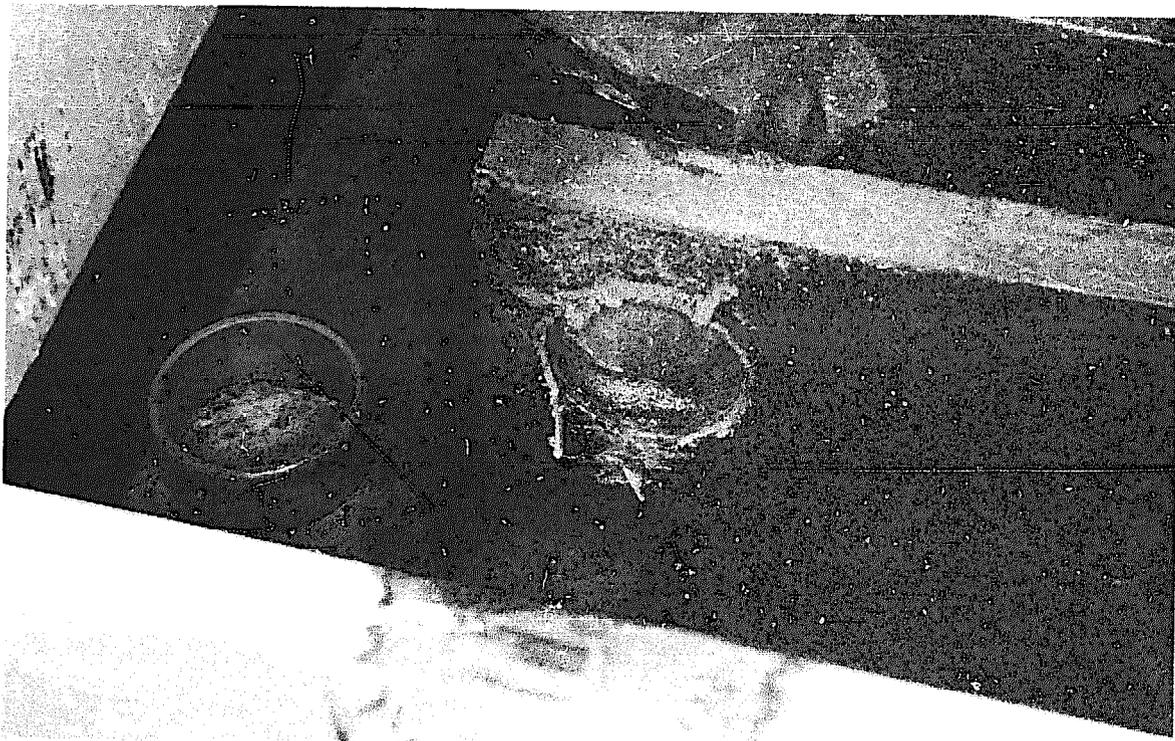
Handle bearings after 1529 hours

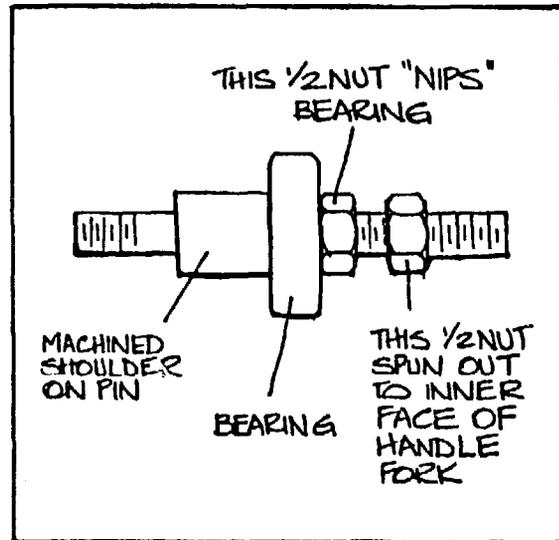
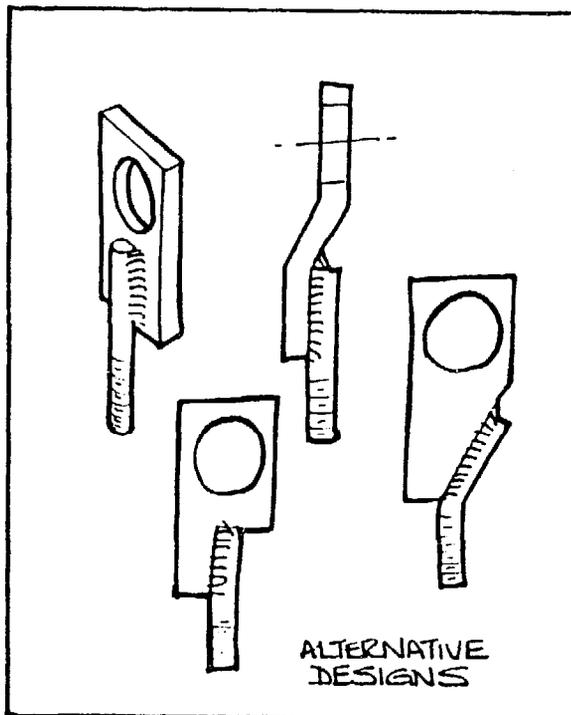
The hanger need not be rounded off at the top and could be designed to eliminate the need for the central slot. See illustration, left.

To reduce, and potentially to eliminate, distortion of the flange plate, it should be cut as a square, with the corners trimmed to avoid any safety hazard. The existing fixing hole centres could be retained.

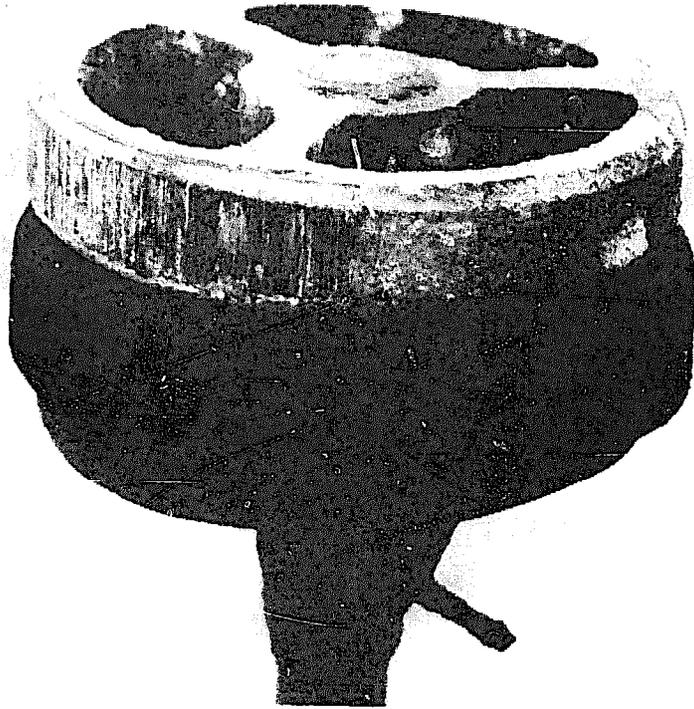
Plunger at end of endurance test

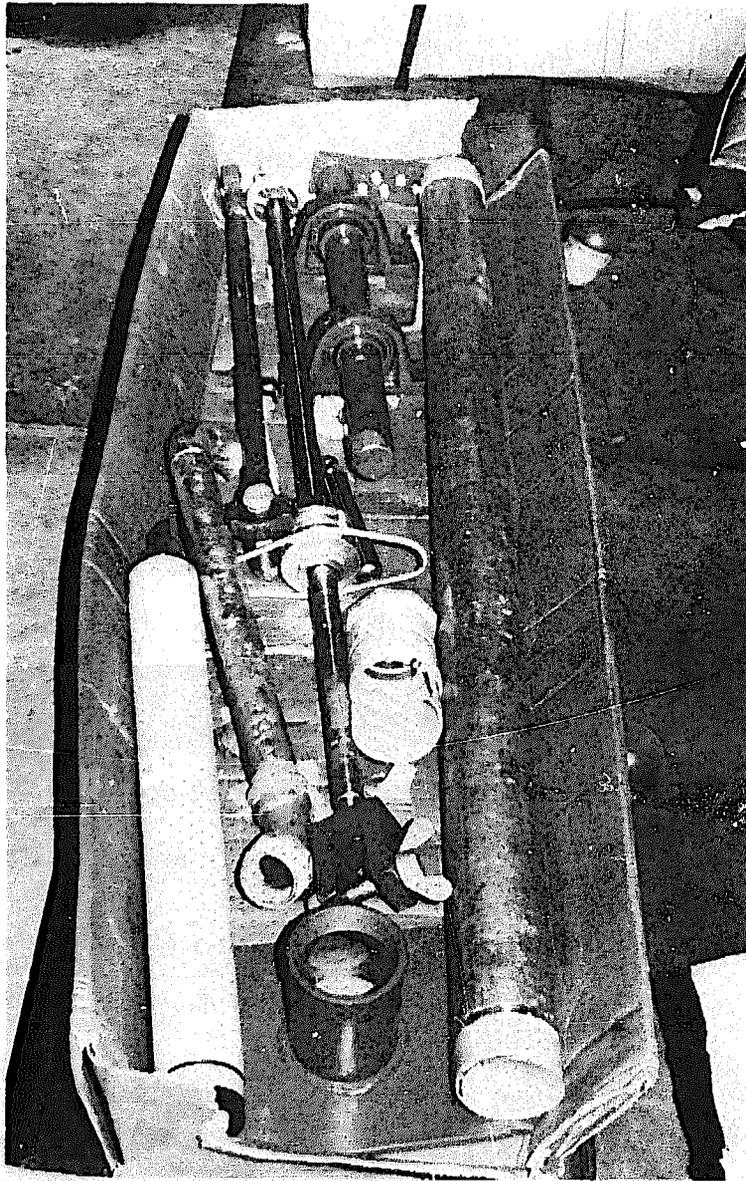
Although the wooden case was satisfactory, the cardboard boxes were unsuitable for the amount of weight put in them, and the components were loose inside. Several components were broken or damaged. The packaging of the pipes was completely unsuitable, four of the six pipes bundled together were damaged in transit.

Inadequate Packaging in Cardboard Boxes

Broken Pipes

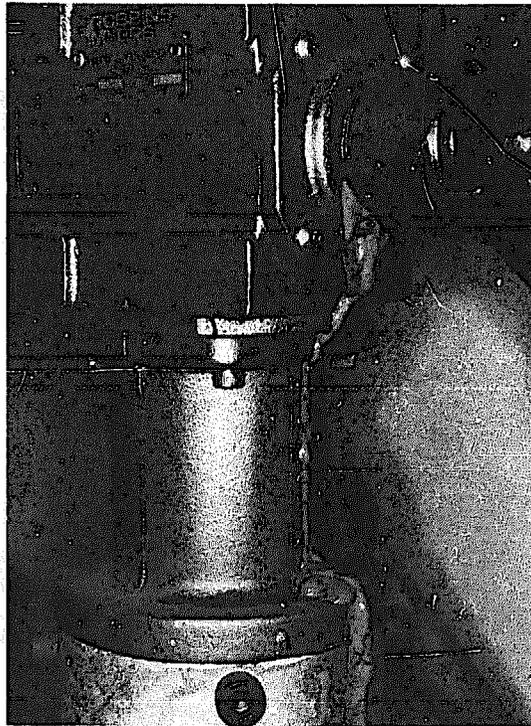
Some grease leaked out of the gearbox through one of the handle bearing seals, see photograph, right, but the final inspection revealed that plenty of grease remained in the gearbox.

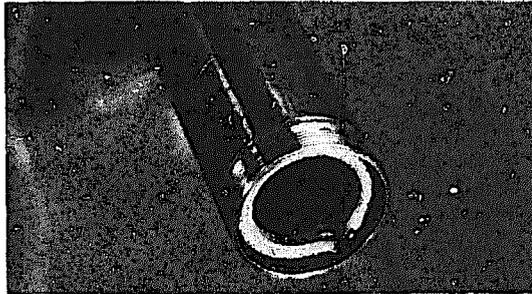
the plunger seals, caused by wrongly-sized sealing cords - see photograph, below. The cords appeared to have been cut to length to suit the machined grooves in the plunger, and with butt joints - as a result they were a poor fit in the cylinder in both samples.

Spare cord had been supplied with the pumps, and new sealing rings were cut to suit the cylinder bore, and with angled, scarf joints. This markedly improved the pump efficiency, from 37% to 71% at 25 metres depth.

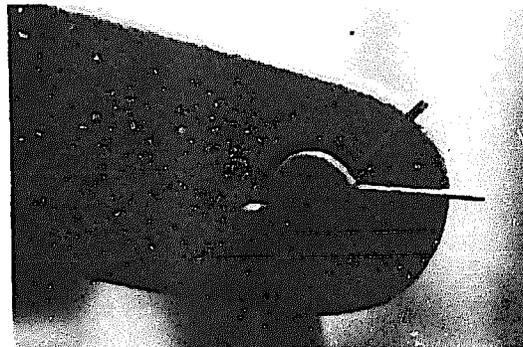
For example, the holes for the handle pivot pins are deliberately drilled oversize to avoid any problems arising from misalignment - see photograph, right.

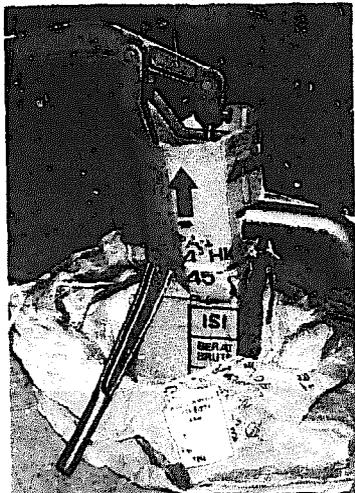
2.1 Packaging The packaging in which these pumps were delivered was very unsuitable.

Each pump was wrapped in pieces of corrugated cardboard and then in a plastic sack - see photograph, left.

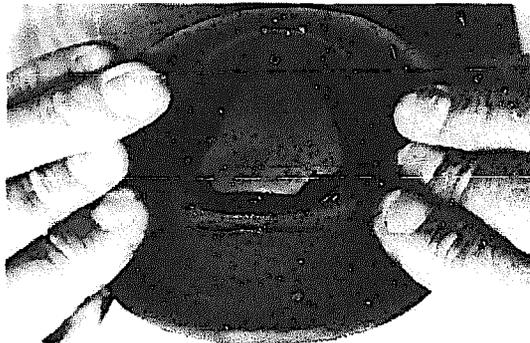
- 1. Pump Body and Handle
 - (a) Cylinder bore in good condition showing no signs of wear
 - (b) Fulcrum pins and bushes all worn, though pump still working
 - (c) Handle no longer contacts bottom stop (because of wear in fulcrum bearings) but fouls on connecting rod eye
- 2. Plunger
 - (a) Plunger valve noticeably worn though still serviceable
 - (b) Some cracks in upper surface of cup washer though still watertight - see photograph, below

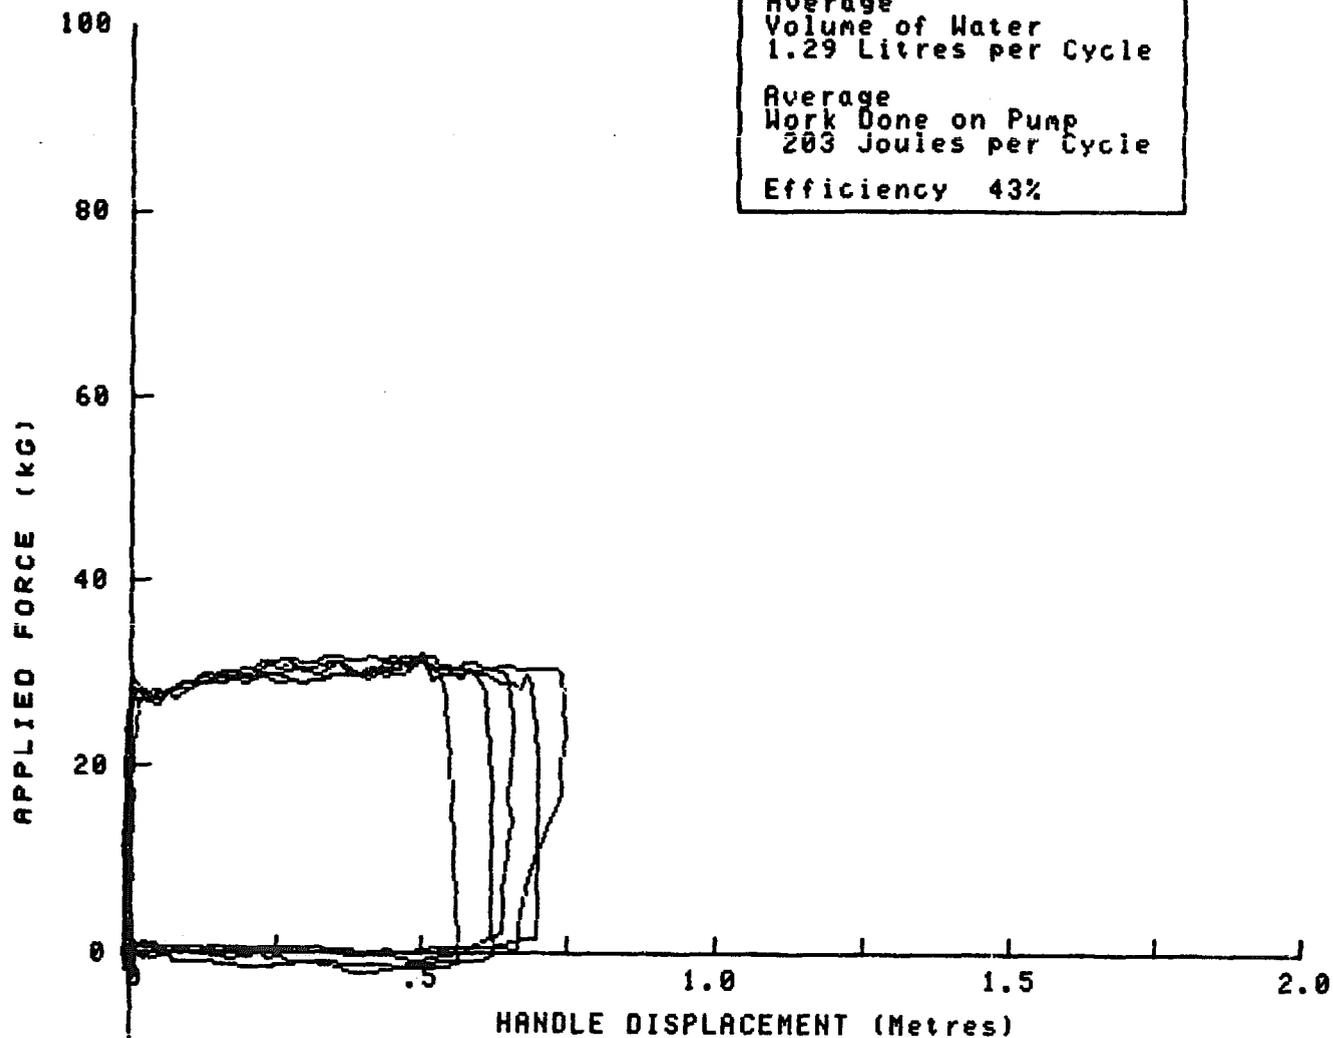
Considerably higher efforts were noted after endurance, possibly due to increased friction between the cup seal and cylinder bore.

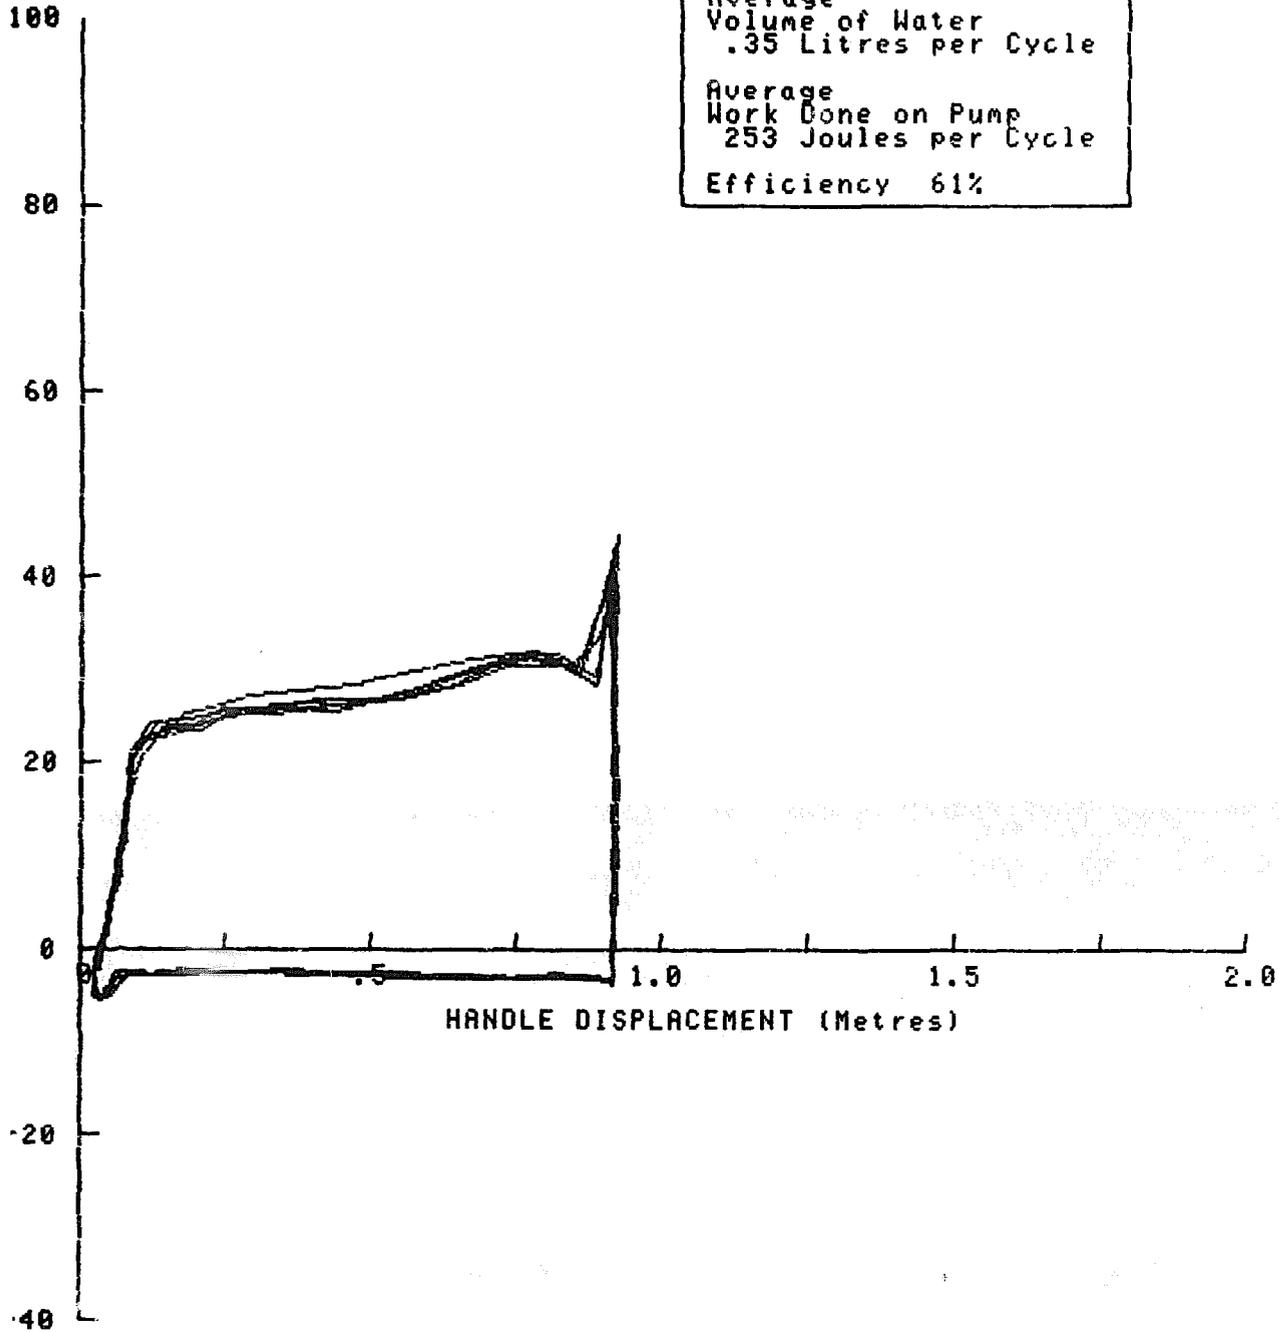
The diagrams illustrate the effects of wear in the pumpstand rack and quadrant:
(a) greater handle displacement for the same volume flow
(b) increased frictional losses, particularly at the start of the return stroke.

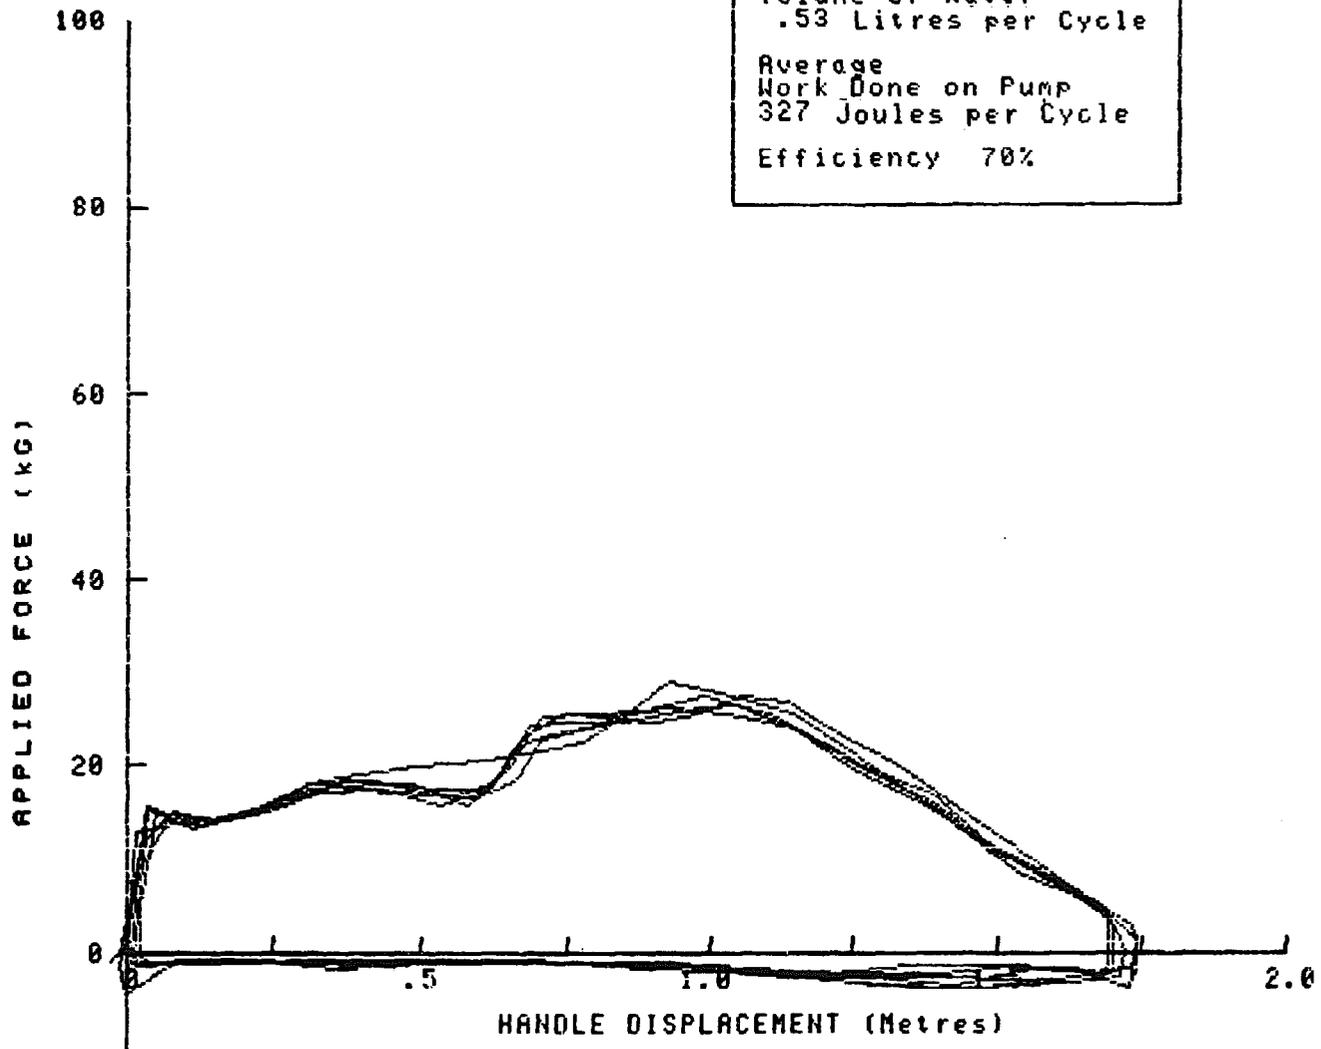
The irregularities on the power stroke are probably caused by variations in the linkage friction due to the wear which has taken place in the linkage mechanism.

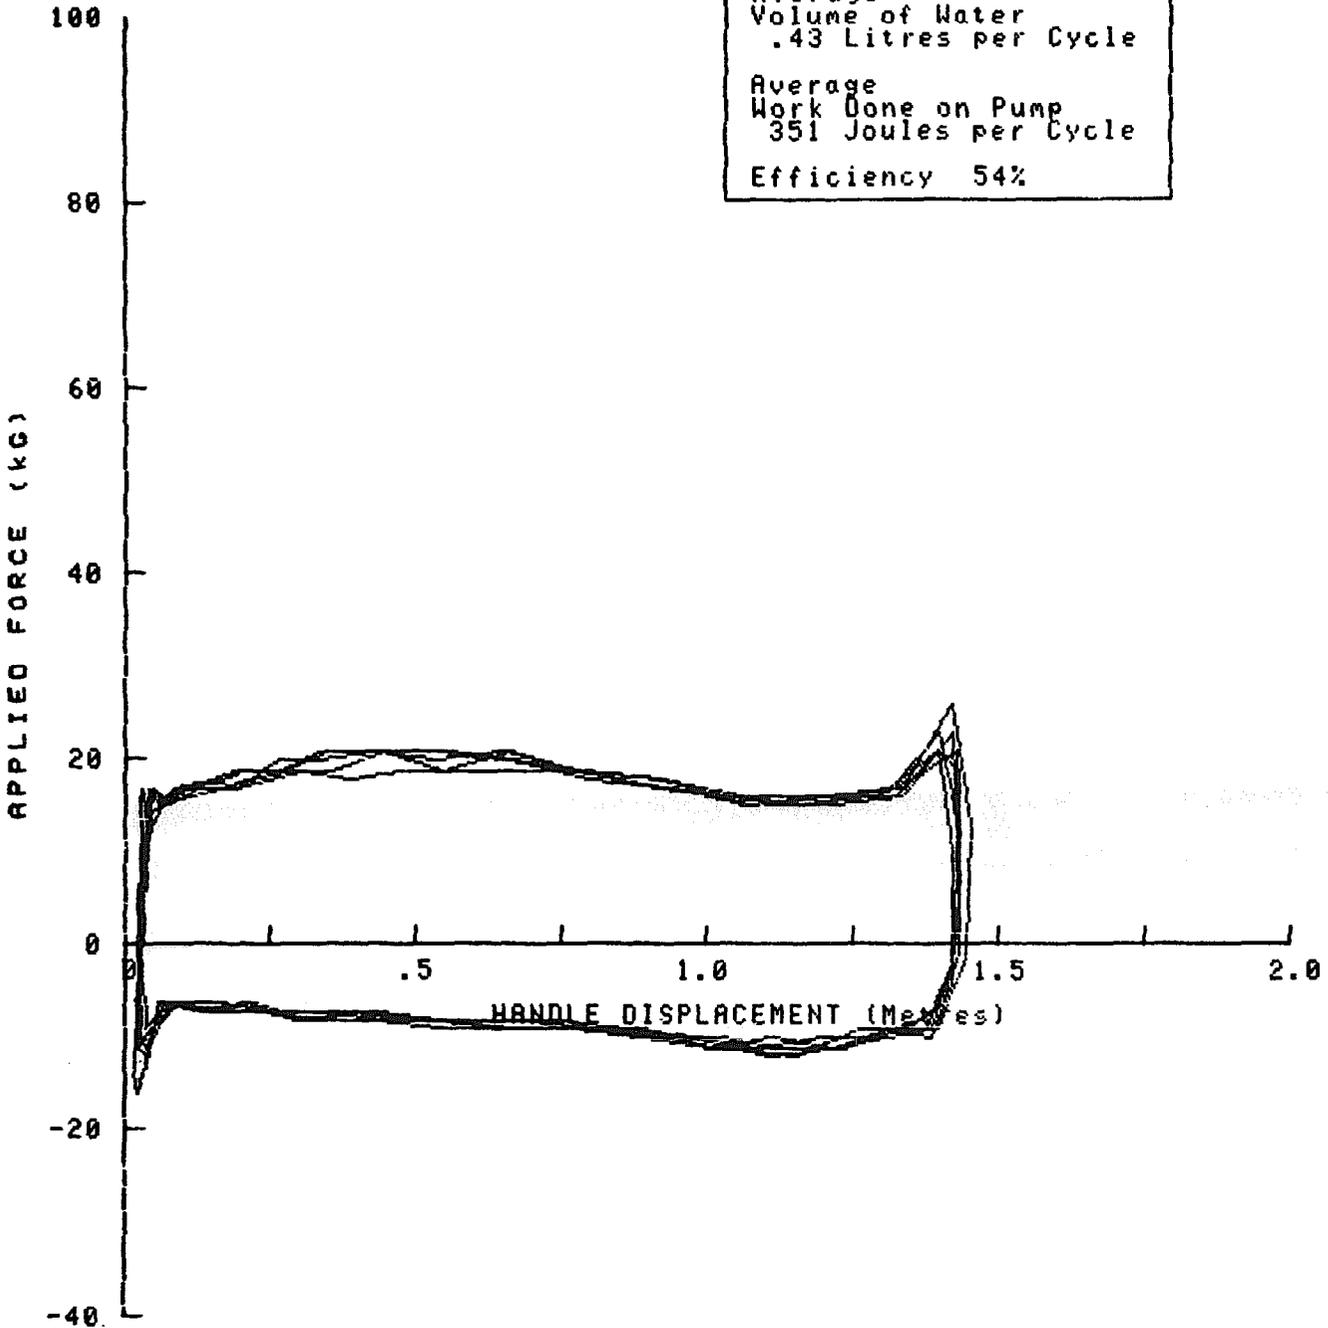
The results show that the work done on the handle increased by over 50% after endurance, with a small increase in volume flow. Friction had therefore increased considerably, probably as a result of the failure of the upper plunger seal.

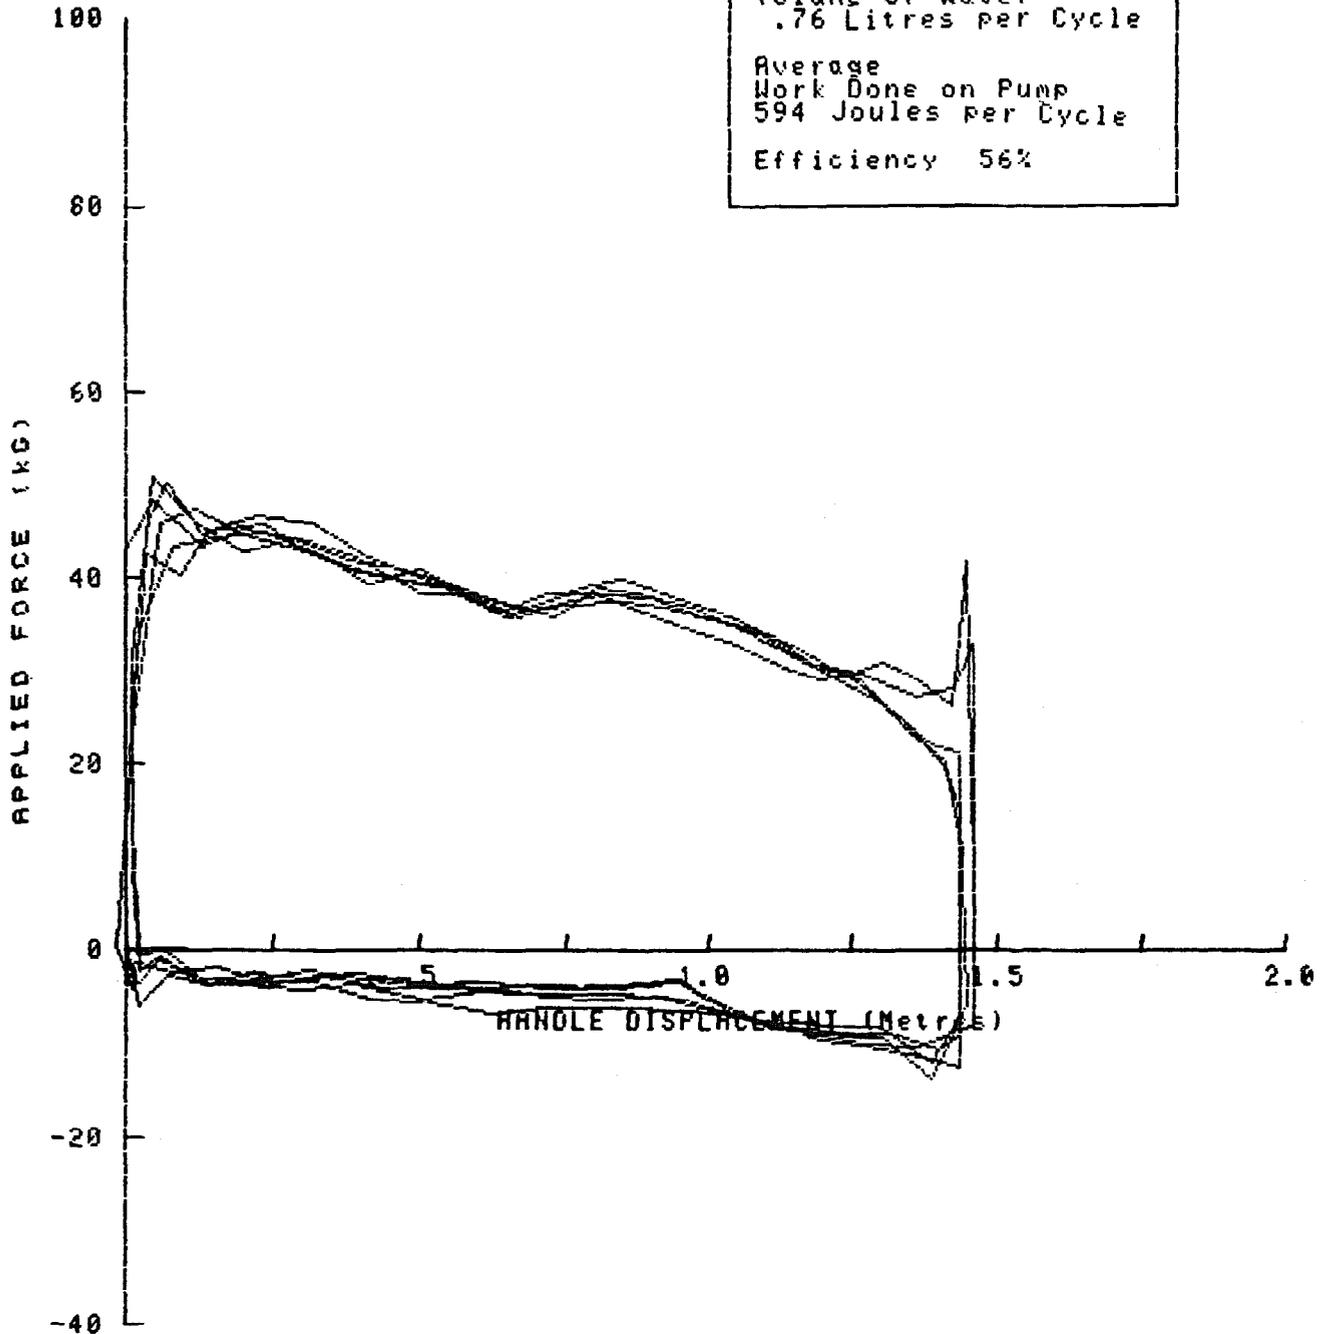
Differences between the profiles of the curves before and after endurance are the result of severe wear at the handle pivot.

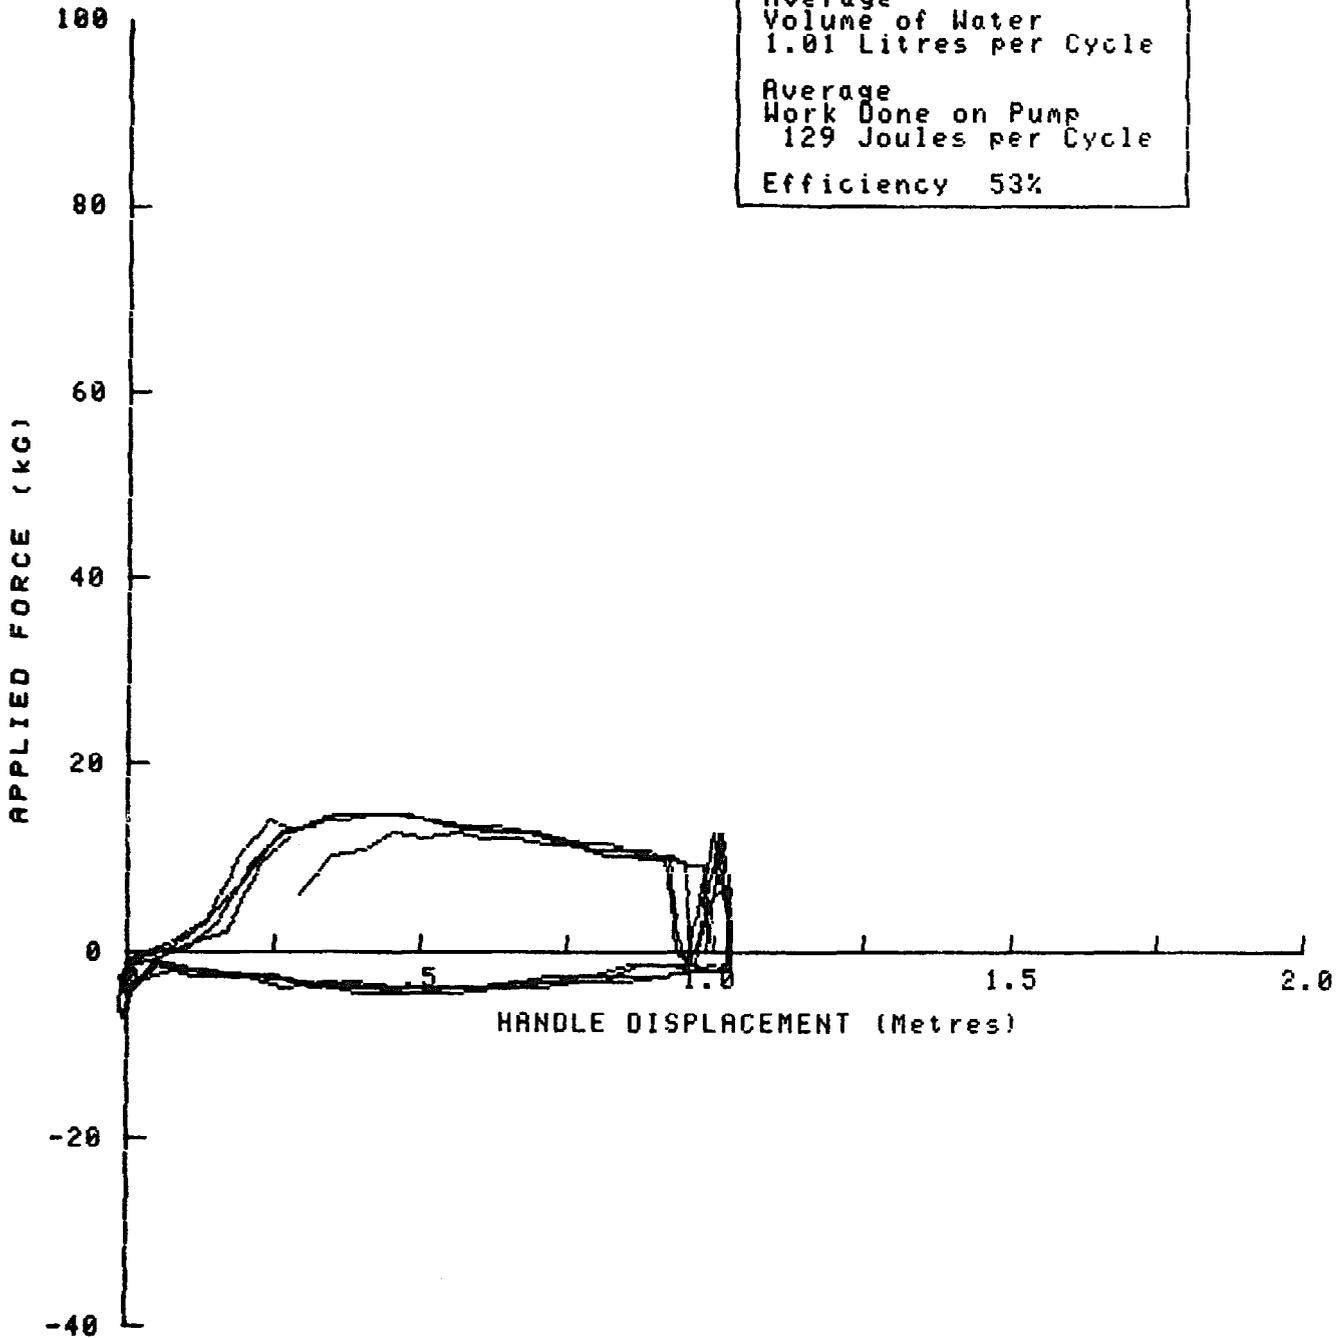
Differences between the profiles of the curves before and after endurance illustrate increased lost motion in the handle pivots.

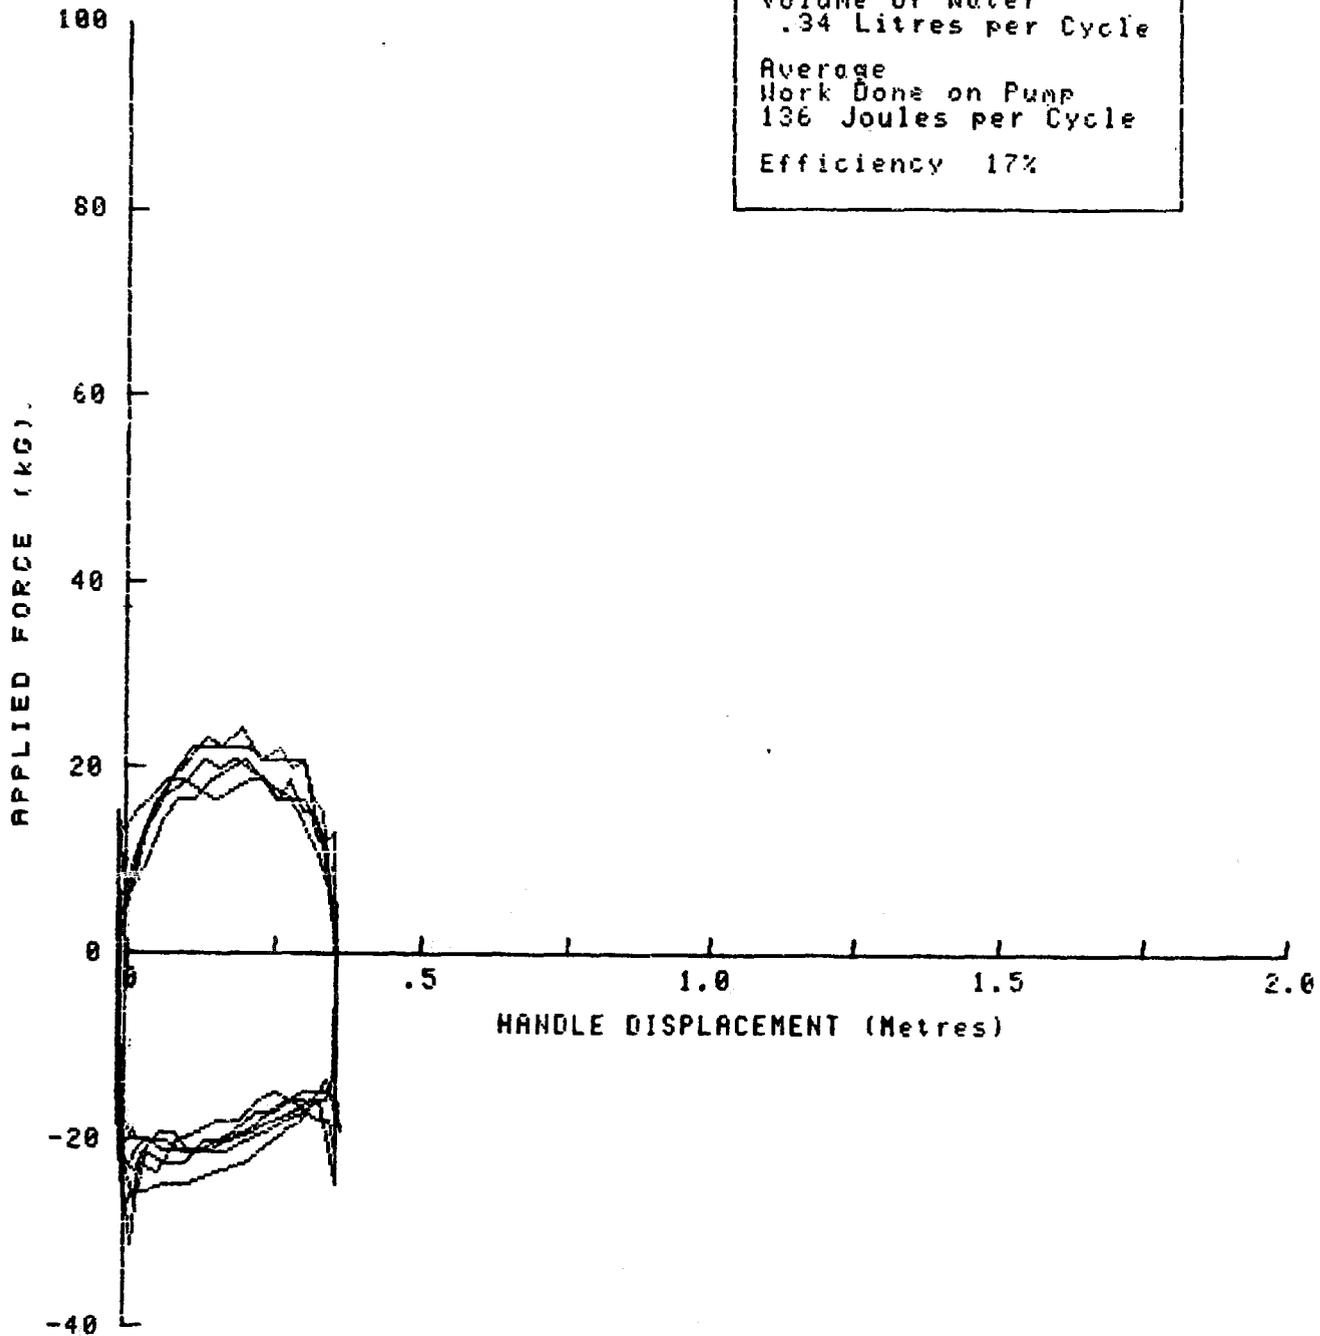
As this pump discharges on the lifting stroke, the power stroke is below the horizontal coordinate. The reduction in force on the power stroke after endurance shows the leakage past the plunger.
