Village Handpump Technology: Research and Evaluation
in Asia, Publication IDRC-204e

Village Handpump Technology

Research and Evaluation in Asia

Editors: Donald Sharp and Michael Graham

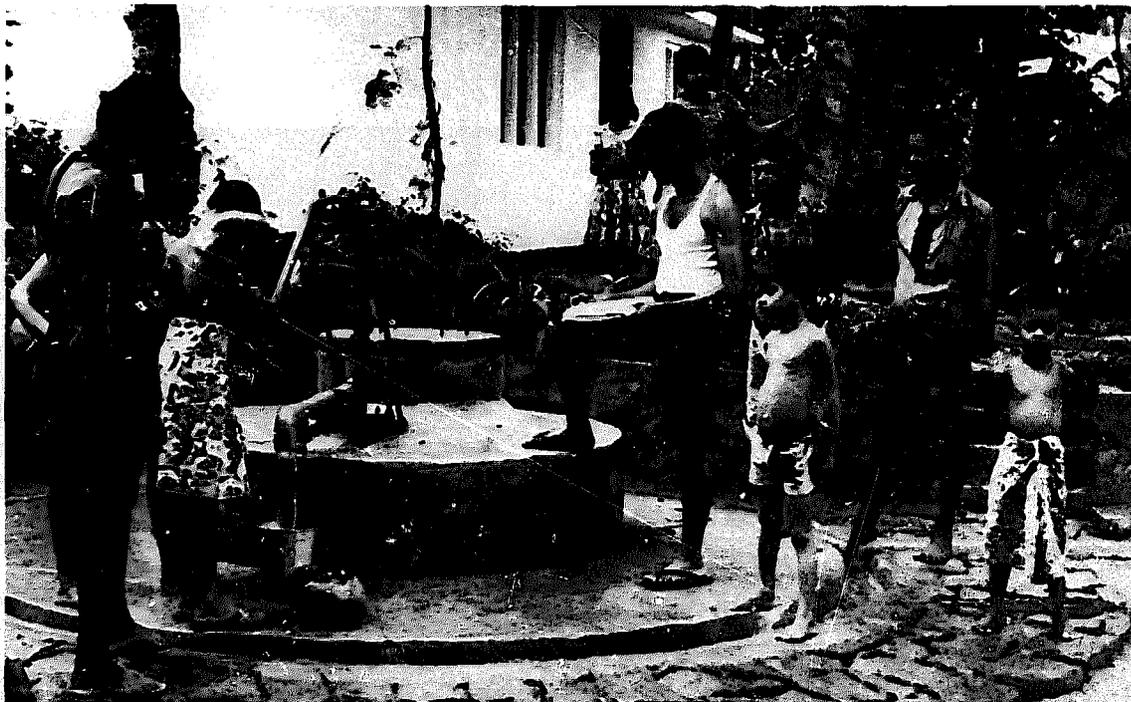
Fig. 1. View of well showing drainage channel to remove spilled water and stone layer to assist drainage.

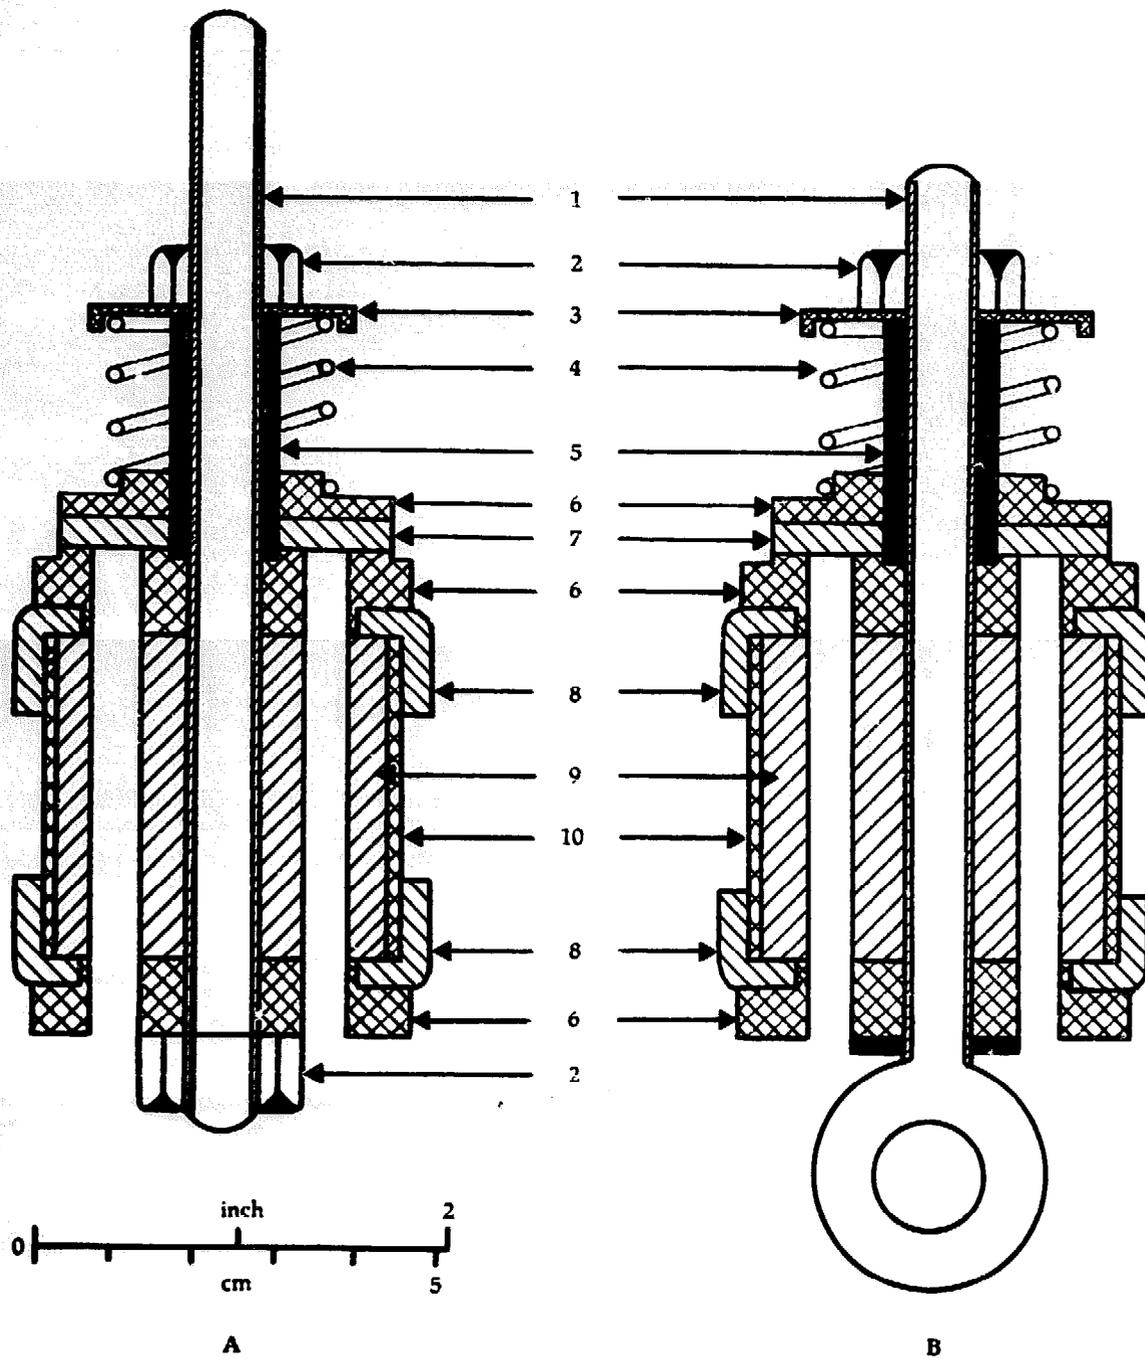
Fig. 2. Details of (A) piston and (B) check valve used in L1 and L3 pumps: (1) "I" bolt; (2) brass nut; (3) PVC cap; (4) brass spring; (5) brass bushing; (6) PVC washer; (7) leather plate valve; (8) leather cup; (9) wood; and (10) PVC pipe.

The problems related to these valves were eventually solved by using a design that combined a hollow PVC pipe with a wooden core and employed leather cup seals. This design (see Fig. 2) completely solved the leakage problem. Not only was the problem of leakage remedied but the wear of the riser pipe was also lessened. When polyethylene rings were used during field testing, the riser pipe wore by 0.35 mm after 90 days of use. This is believed to be due to silt particles becoming embedded in the rings and acting like sandpaper against the cylinder wall. Similar tests with leather cups produced much less wear. This design makes local fabrication and repair possible and it has proven its reliability under field conditions for over 1 year.

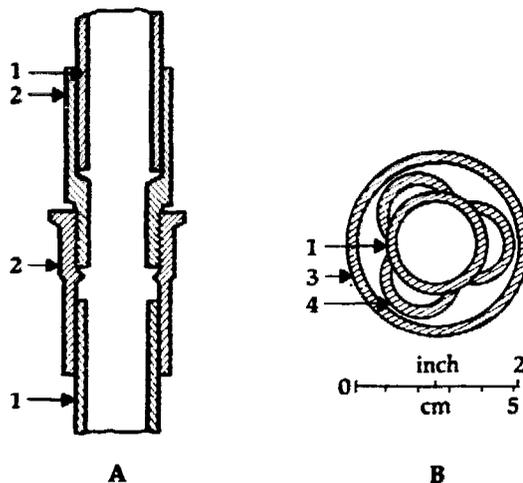
Fig. 3. (A) Threaded PVC piston rod couplings and (B) PVC piston rod guides glued to piston rod to reduce vibration during operation of pump: (1) connecting rod; (2) threaded coupling; (3) riser pipe; and (4) rod guides.

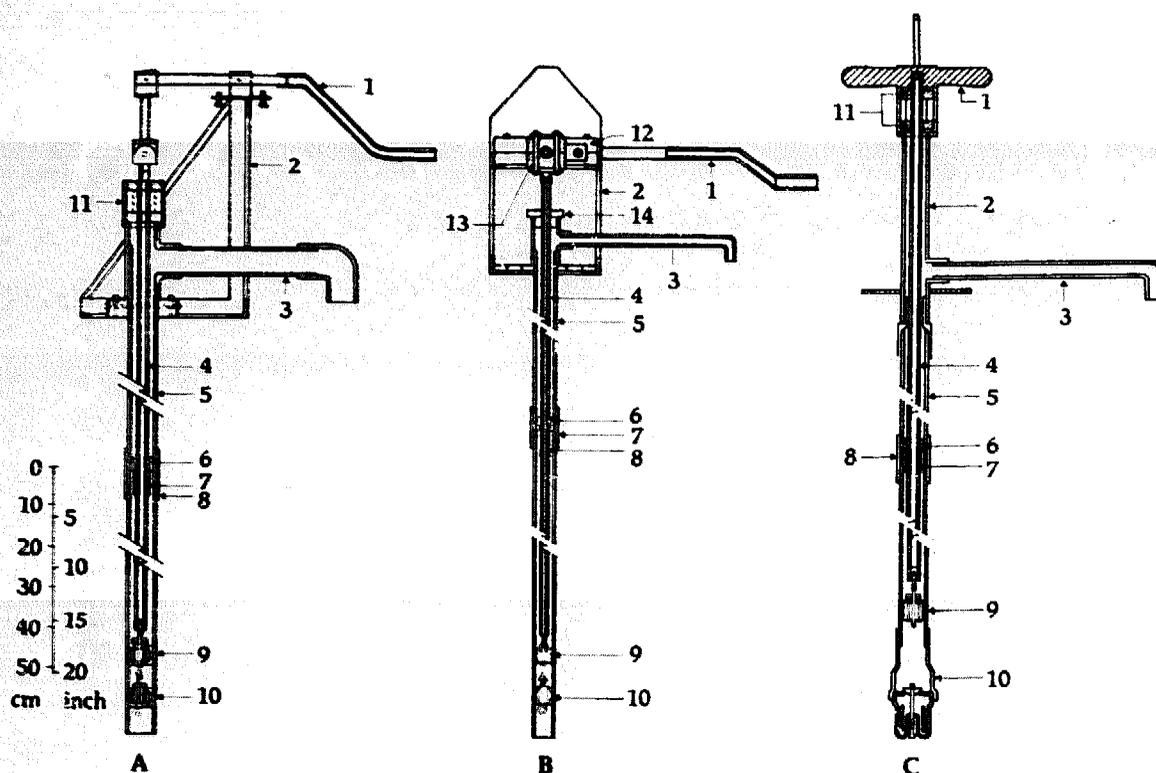
Fig. 4. (A) L1 pump, (B) L3 pump, and (C) V1 pump: (1) handle; (2) frame; (3) spout; (4) piston rod; (5) riser pipe; (6) piston rod guide; (7) piston rod joint; (8) riser pipe joint; (9) piston; (10) check valve; (11) wooden bearing and counter box (L1 and V1); (12) main bearing (L3); (13) big-end bearing (L3); and (14) counter base (L3).

For field-testing, a total of six of these pumps were installed. Four at Talawa and one each at Ginimallagaha and at the Sarvodaya Main Centre. These pumps were used to replace the L2 pumps that had been installed originally in these wells. The frame of the L2 was made out of concrete and used a wooden handle. The original L3 pumps also used a handle that pivoted on a bearing fixed in a concrete pedestal. Although this arrangement proved more successful than the L2 pump, it also had to be changed because of excessive, and rapid, wear of the wood at the pivot point. This meant that the handle could be lowered to the point where it would make contact with the outlet spout, resulting in a constant banging by the handle during the operation of the pump that resulted in the joint between the pump head and the spout cracking. This problem was remedied by designing a new handle that prevented overlowering and at the same time made the pump easier to operate (Fig. 4).

components of these pumps (see Table 1 and Fig. 4) worked well and did not require modification. Originally, a 7.5-cm cylinder was used for the riser pipe and a 5-cm pipe was used for the above-ground portion of the pipe. However, this meant that the 7.5-cm piston could not be removed for repairs without cutting the cylinder. To make repairs easier and to save time and labour, a 5-cm piston is now used along with a 5-cm pipe for the entire length of the riser pipe and cylinder.

Nine of the V1 pumps (Fig. 4) have been installed: four at Akurala; four at Yatiyana; and one at Hingurudugoda. The wells at these sites are 3–4 m deep. The above-ground components of this pump were modified based on our experience, the results of the field testing, and the suggestions of the users. We found that the original metal handle made this pump difficult to operate, therefore we switched to a wooden handle. We also discovered that the piston could be pulled out of

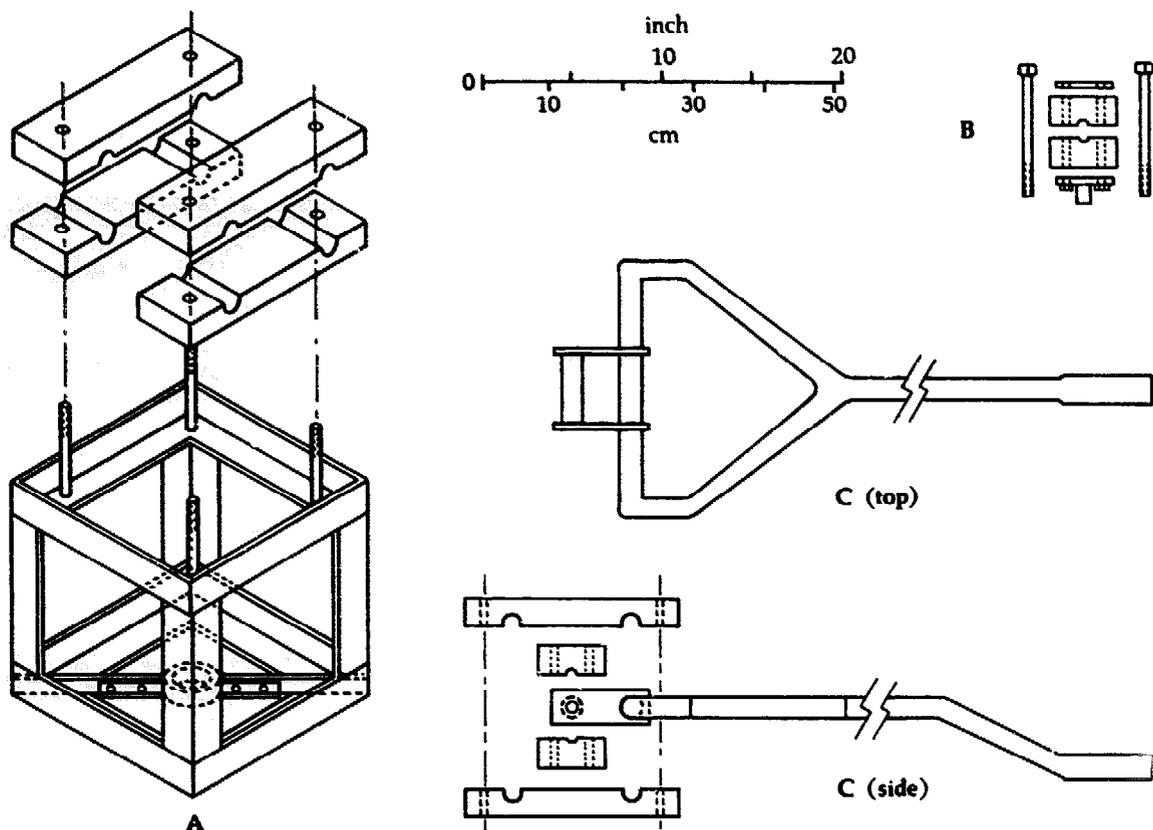
Fig. 5. Details of L3 pump: (A) frame and wooden bearings, (B) big-end bearing, and (C) final handle design showing position of wooden bearings.

Bearings Wood (satin or palu) is used for both sets of bearings. One set is fitted to the piston rod. The other set is used for the pivot point in the handle and is designed so that the bearing can be reversed once wear is excessive, thus prolonging the life of the bearing (Fig. 5).

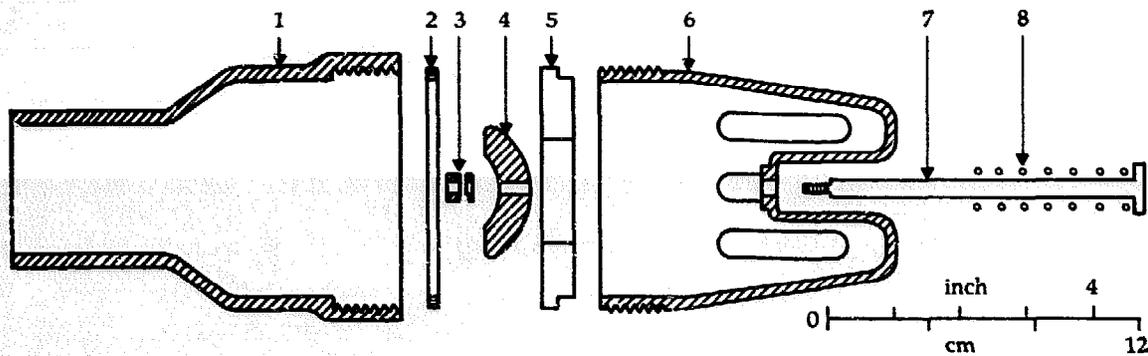
Fig. 7. Details of check valve used in V1 pumps: (1) PVC cover; (2) rubber ring; (3) brass nut and washer; (4) rubber check valve; (5) PVC plate; (6) PVC screen; (7) brass bolt; and (8) brass spring.

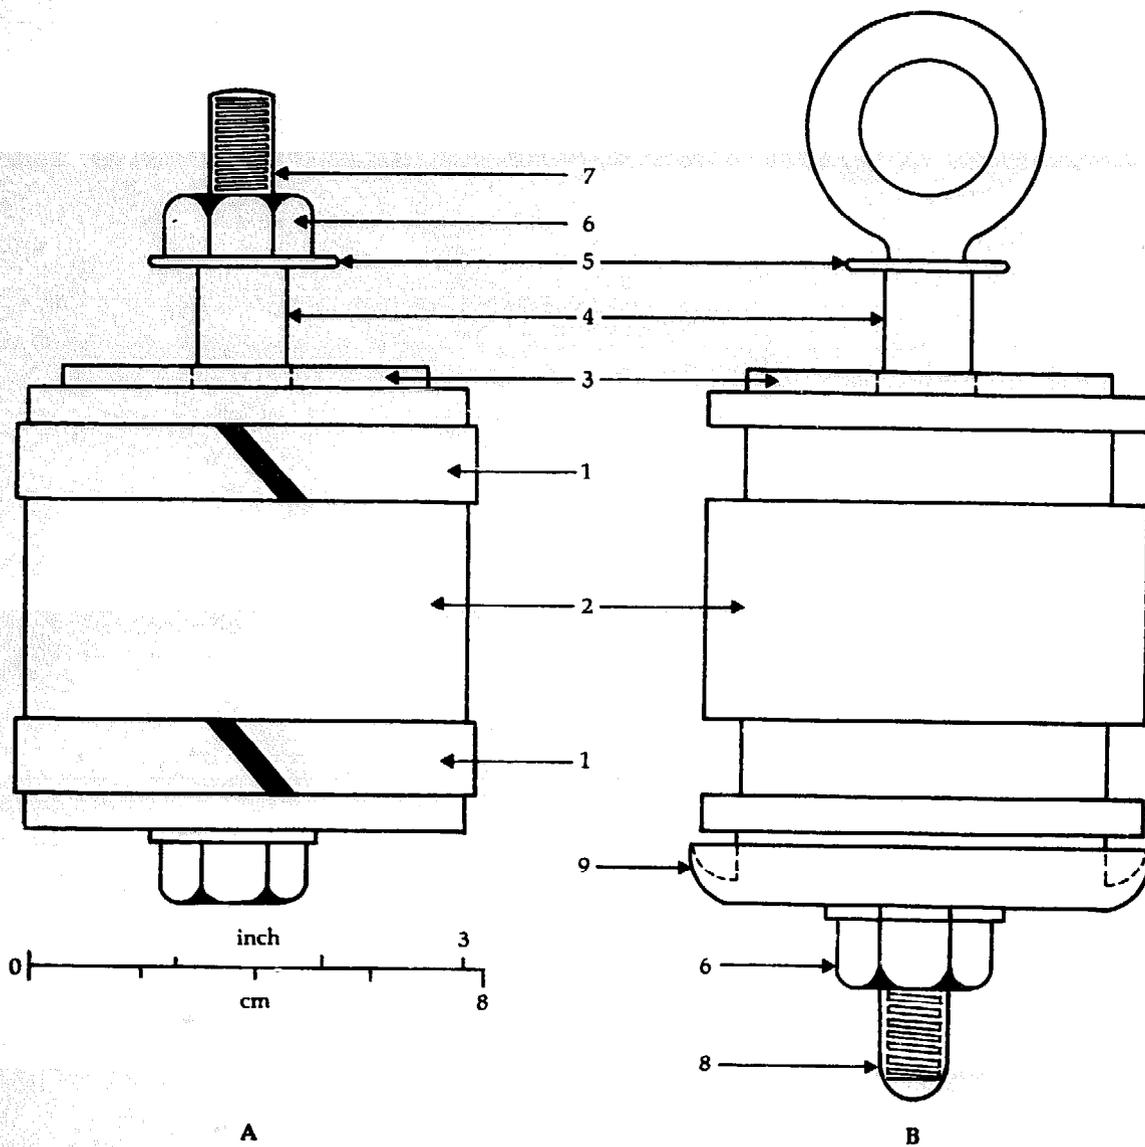
Fig. 1. (A) Piston and (B) foot-valve assembly of Waterloo handpump: (1) polyethylene ring; (2) piston; (3) PVC plate valve; (4) brass valve guide; (5) flat washer; (6) nut; (7) bolt; (8) bolt with eye; and (9) polyethylene foot-valve adapter.

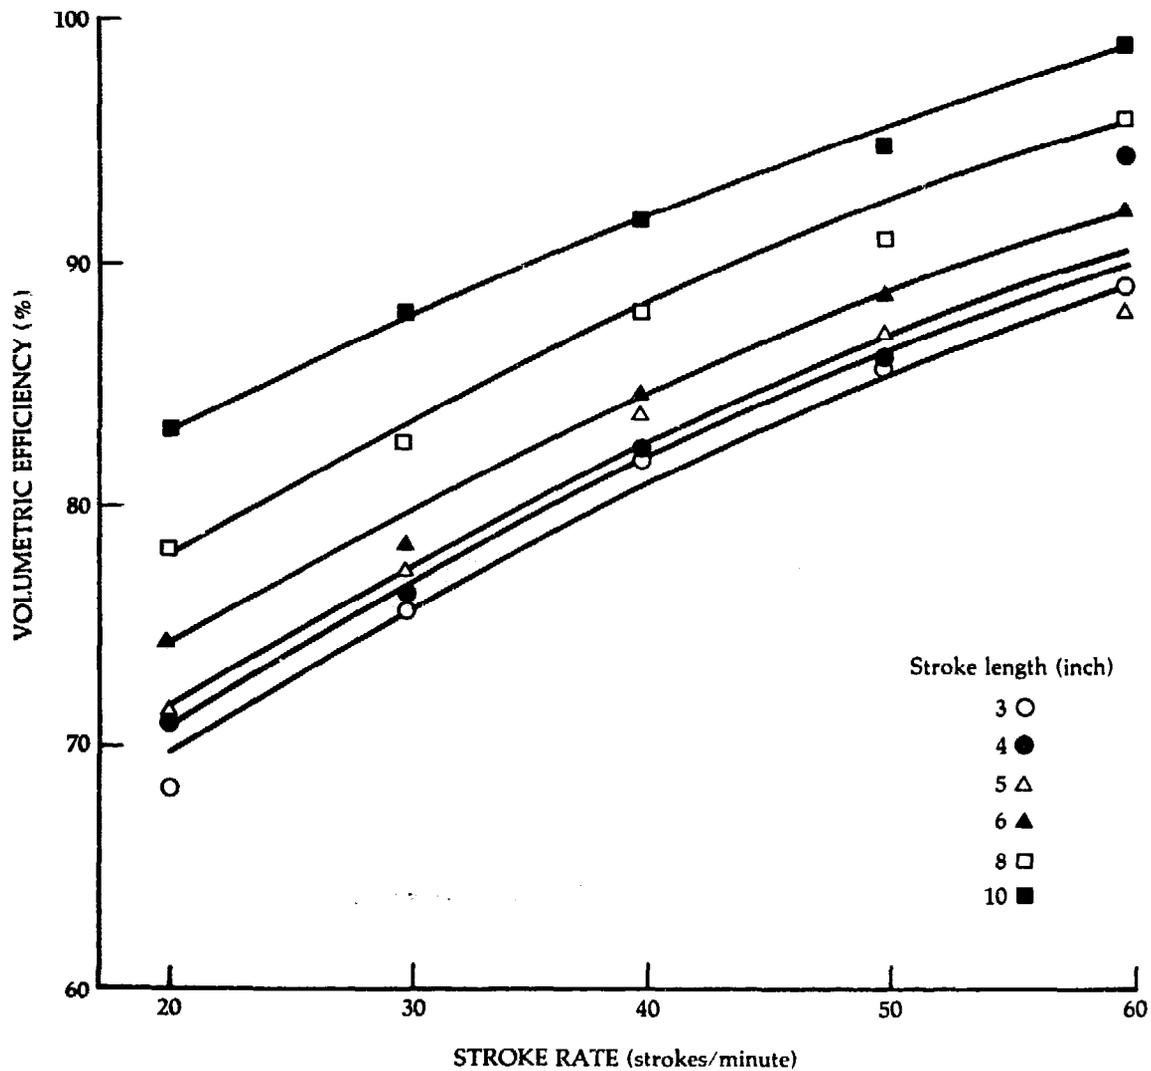
Fig. 2. Influence of stroke lengths on volumetric efficiency of Waterloo pumps having 12.5% orifice/piston area ratio. (Water head, 15 feet (4.57 m); piston diameter, 3 inches (7.5 cm); valve gap, 0.25 inch (0.6 cm); piston foot-valve clearance, 12 inches (30 cm).)

The influence of piston stroke length on the volumetric efficiency of Waterloo pumps having orifice/piston area ratios of 12.5, 17.0, and 22.2% was plotted against the speed of the piston for all pumps. An example of the result is given in Fig. 2. The piston diameter, the gap of the foot valve, the piston foot valve, and the water head clearance were kept constant throughout these tests. The volumetric efficiency of the pump increased as the piston stroke length as well as the speed of the piston increased. The influence of orifice/piston area ratios on the volumetric efficiency of Waterloo pumps having piston strokes of 4, 6, and 8 inches (10, 15, and 20 cm) were also determined. The results for a 6-inch (15-cm) stroke are given in Fig. 3. The results indicated that, for a piston stroke of 4 inches (10 cm), the orifice/piston area ratio had little effect on the volumetric efficiency of the pump. However, for longer piston strokes, the volumetric efficiency of the Waterloo pump increased as the orifice/piston area

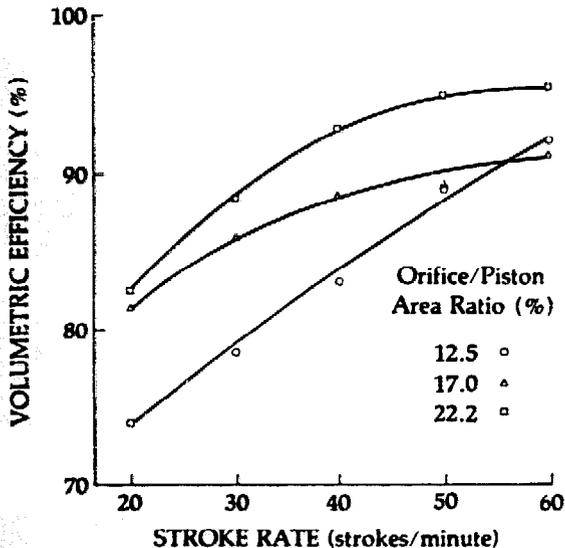
Fig. 3. Influence of orifice/piston area ratio on volumetric efficiency of Waterloo pumps having 6-inch (15-cm) stroke length. (Water head, 15 feet (4.57 m); piston diameter, 3 inches (7.5 cm); valve gap, 0.25 inch (0.6 cm).)

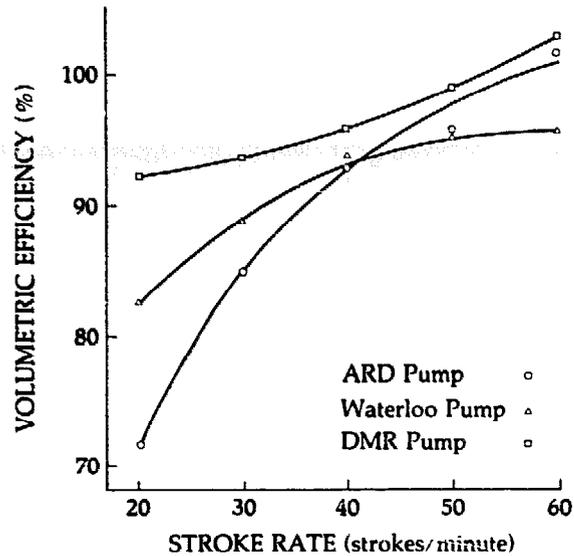
Fig. 4. Comparison of volumetric efficiencies for different pumps having 6-inch (15-cm) stroke length.

The performance of DMR and ARD handpumps under laboratory conditions was also plotted. At low speeds of piston movement, the volumetric efficiency of ARD handpumps was lower than that of DMR handpumps. At higher speeds of piston movement, however, the volumetric efficiency of ARD handpumps improved significantly. At very high piston speeds, the volumetric efficiency of the DMR handpumps exceeded 100%. This can be explained by the fact that, when the pump is operated at very high speed, extra water from the riser pipe is pumped up.

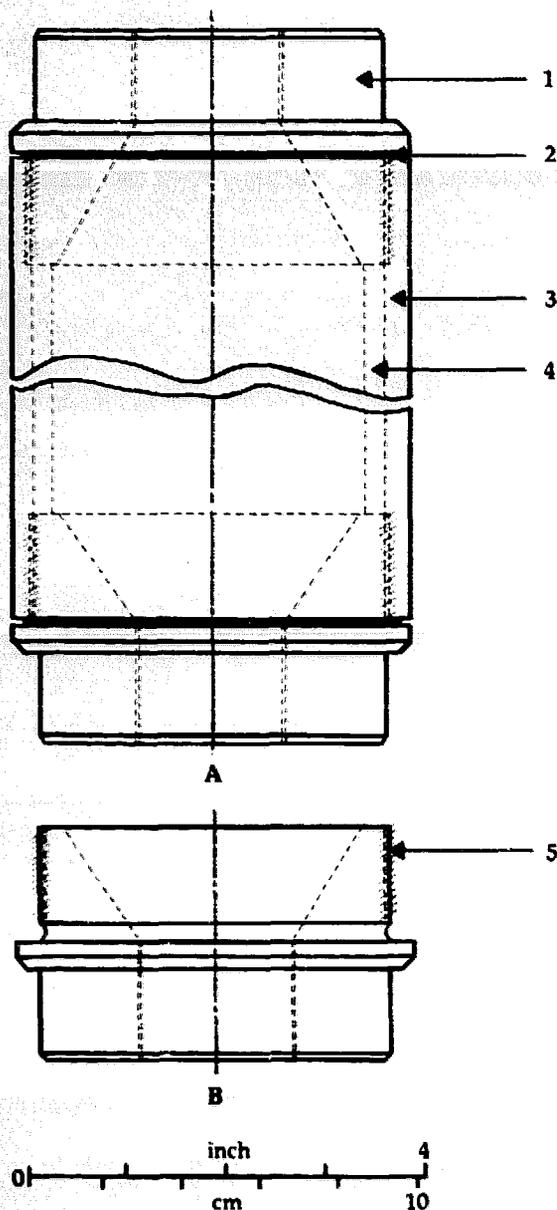
Fig. 5. Modified 3-inch (7.5-cm) diameter cylinder (A) and steel cap (B): (1) steel cap; (2) rubber O-ring; (3) steel casing; (4) PVC lining; and (5) threaded section. (Total height of cylinder is 27 inches (68.6 cm).)

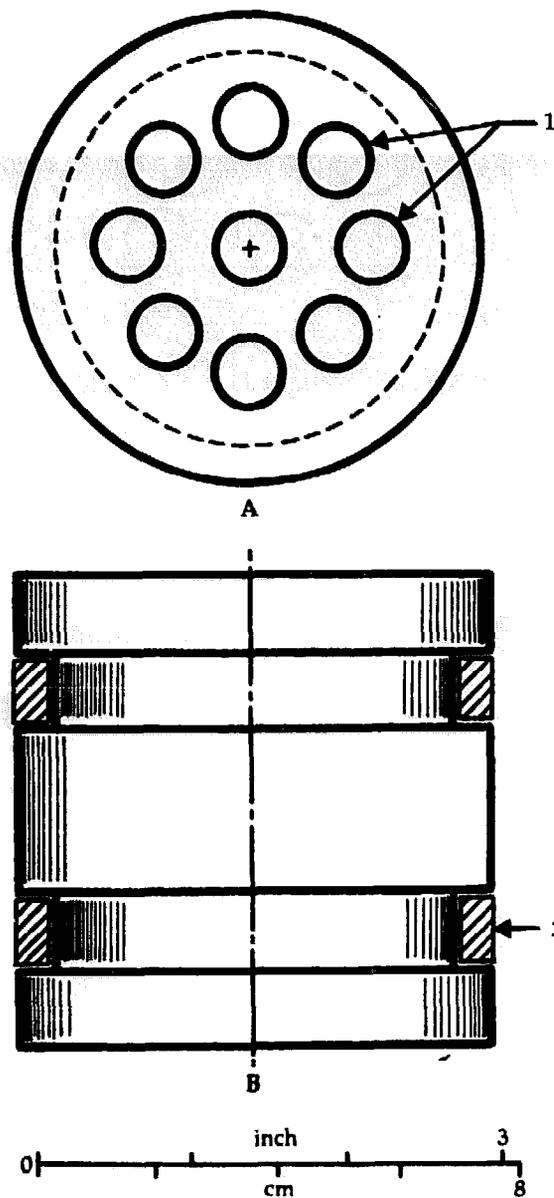
Fig. 6. (A) Top and (B) side views of modified piston of Waterloo handpump; (1) 7/16-inch (1.11-cm) holes; and (2) PVC piston ring.

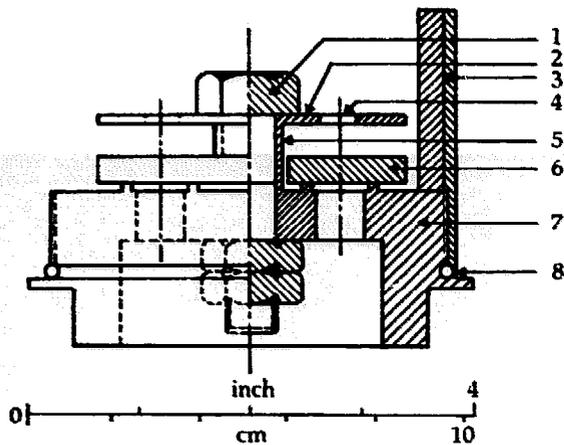
Fig. 7. Third modification of PVC foot valve: (1) threaded bolt; (2) stainless-steel plate; (3) PVC lining and steel casing; (4) 7/16-inch (1.11-cm) holes on 1.5-inch (3.8-cm) pitch diameter; (5) brass guide; (6) rubber plate valve; (7) steel cap; and (8) O-ring.

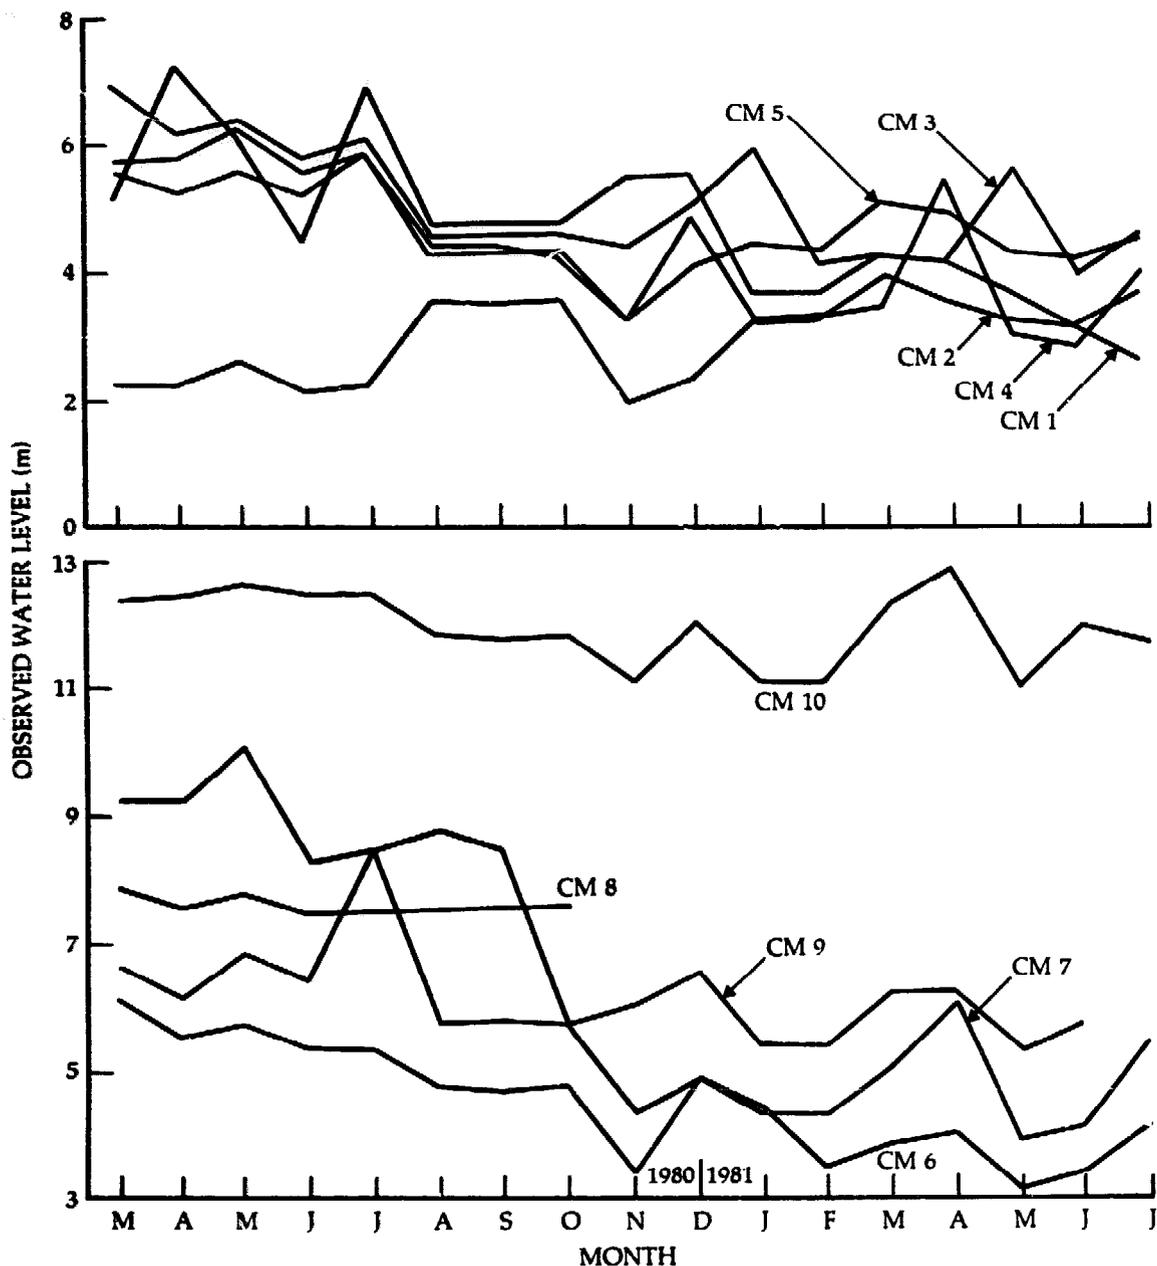
Fig. 8. Observed static water levels of wells located in Chiang Mai (CM3-9) and Lamphun (CM1, 2, and 10).

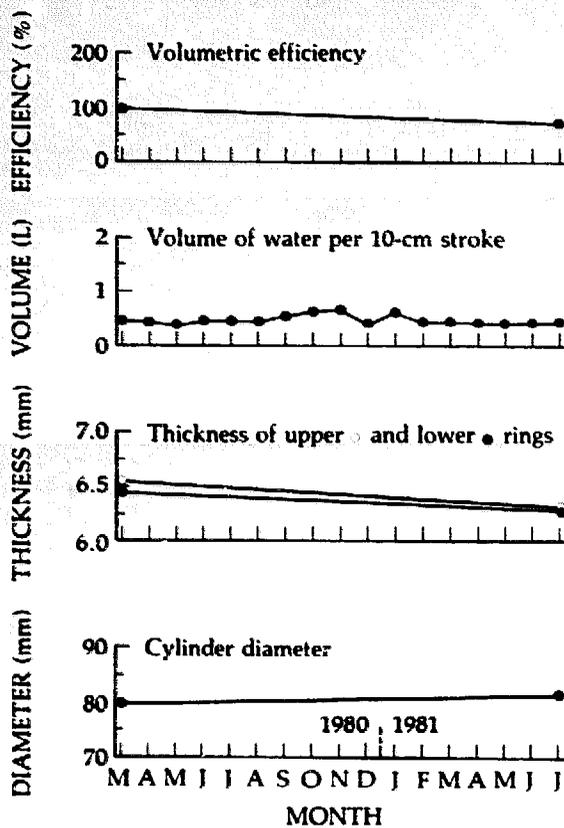
Fig. 9. Performance of 3-inch (7.5-cm) cylinder handpump in Saraburi and Lopburi regions.

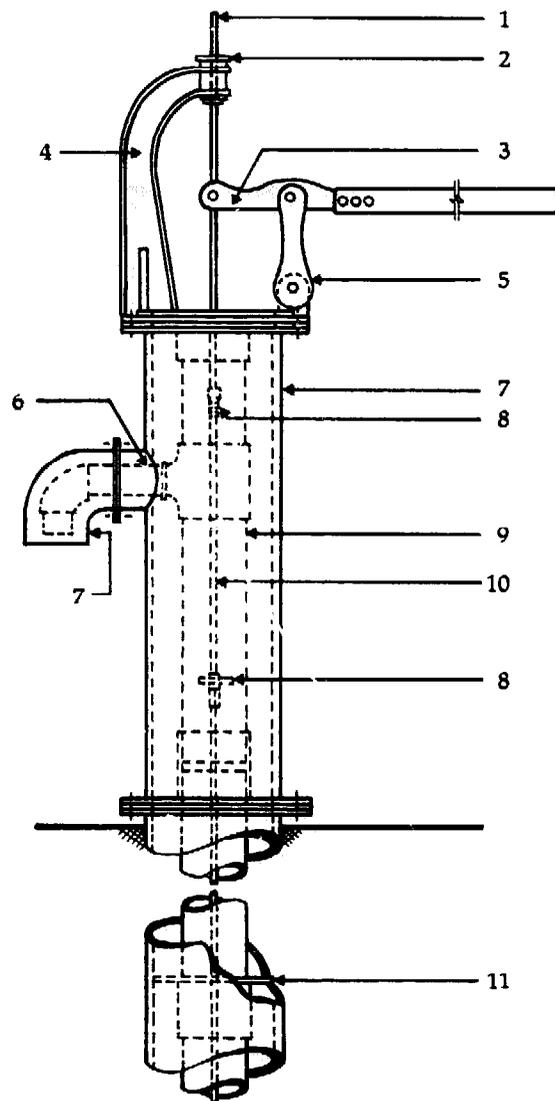
Fig. 10. Above-ground components of AIT-PVC handpump: (1) round steel bar; (2) bar guide; (3) handle; (4) frame; (5) handle-support joint with ball bearings; (6) PVC faucet; (7) steel casing; (8) coupling; (9) PVC pipe; (10) steel rod; and (11) wooden spacer.

duced in this design. This fulcrum link replaces the type used in the DMR handpump, which failed frequently either at the joints or at the link itself. Details of the above-ground components are shown in Fig. 10.

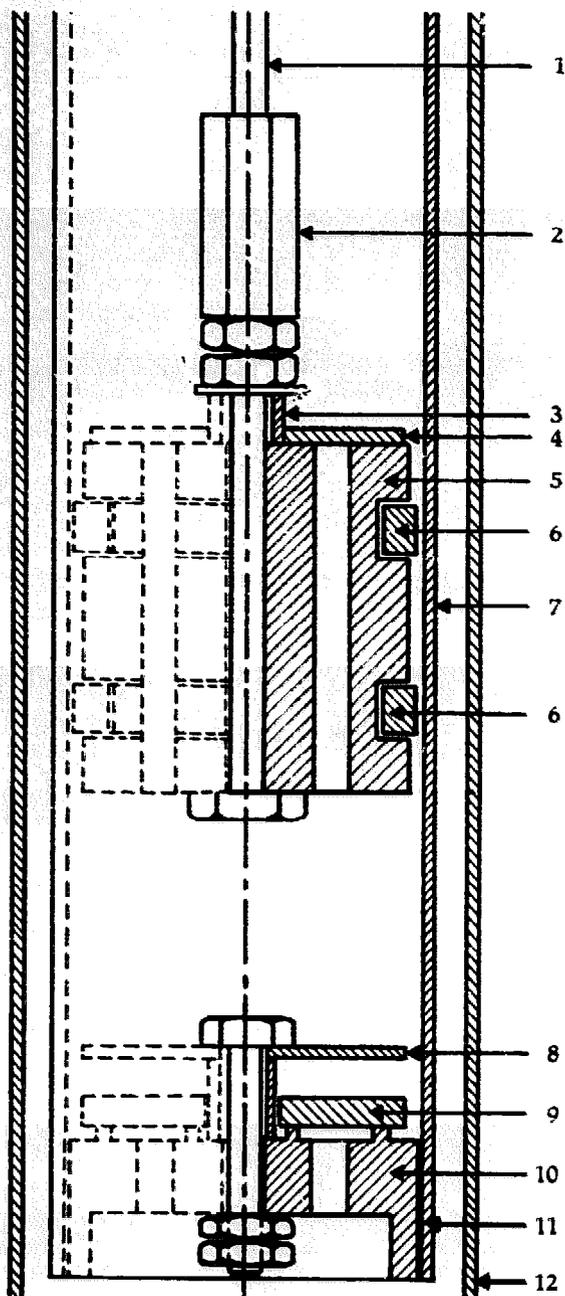
Fig. 11. Below-ground components of AIT-PVC hand-pump: (1) steel rod; (2) coupling; (3) brass guide; (4) PVC piston valve; (5) PVC piston; (6) PVC piston ring; (7) PVC pipe; (8) stainless-steel plate; (9) rubber foot-valve plate; (10) PVC foot valve; (11) solvent cement glue; and (12) steel well casing.

The riser pipe is made of standard 3-inch (7.5-cm) diameter PVC pipe 4 m (13.1 feet) long. This pipe is also used as the cylinder. The modified piston and foot valve (Figs. 6 and 7) discussed earlier were adopted in this new design. The only part not made of PVC is the 7/16-inch (11-cm) pump rod. Initially, a standard hollow 3/4-inch (2-cm) diameter PVC pipe was used for the pump rod but this was not strong or durable enough to withstand the pumping force. Even the steel pump rod was found to be insufficient and, as a result, a spacer is introduced at the

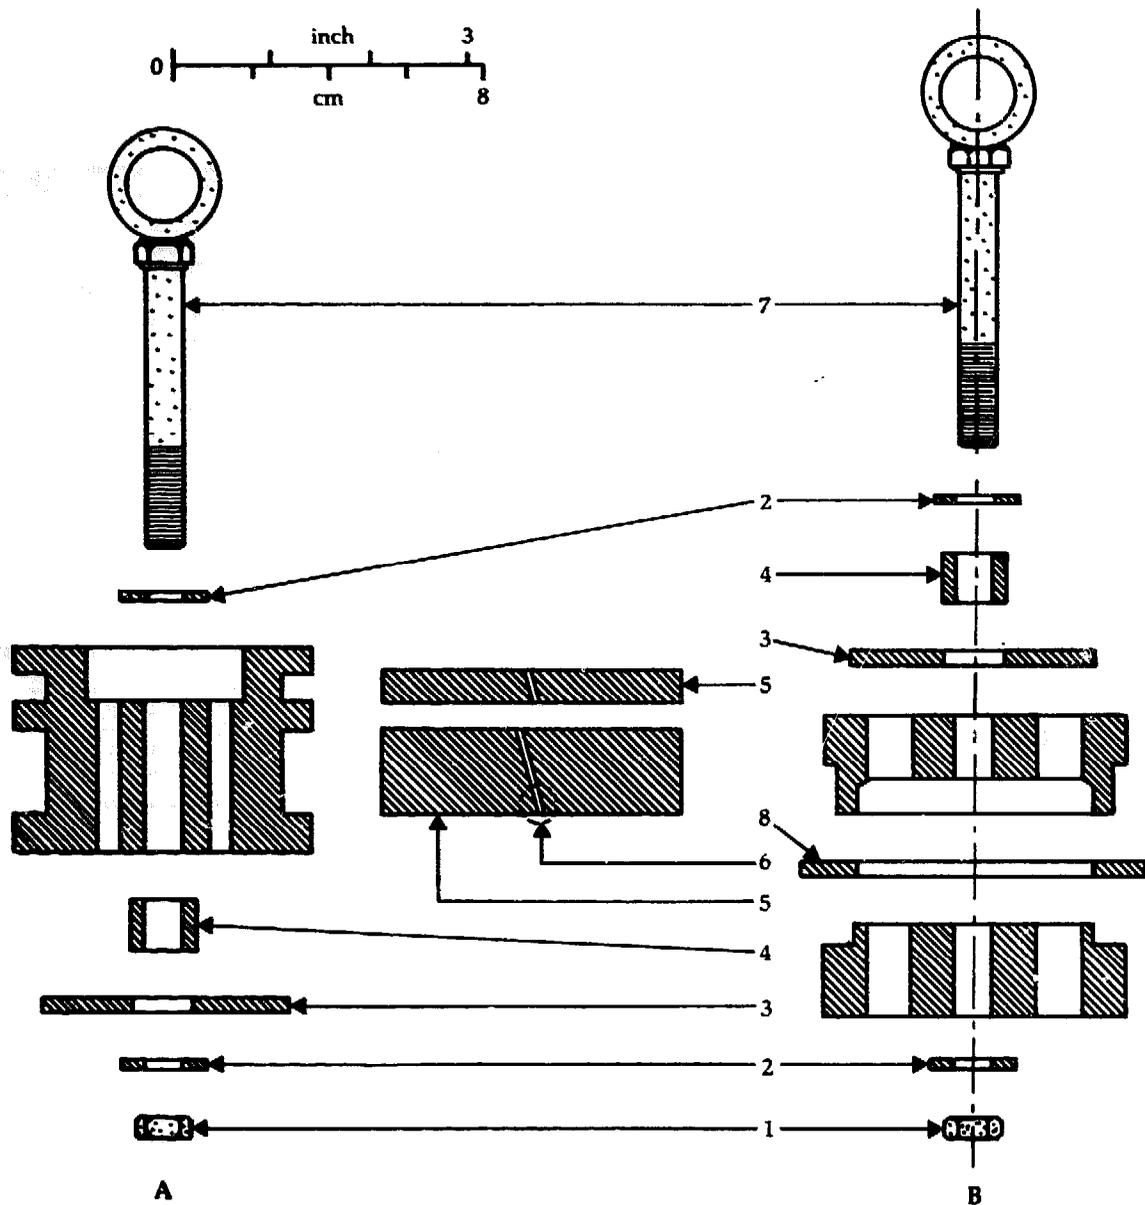
Fig. 1. (A) Piston and (B) original foot valve: (1) hex nut; (2) plain washer; (3) plastic valve cap; (4) value-cap slip guide; (5) plastic piston ring; (6) diagonal cut; (7) threaded bolt with O-ring welded in place; and (8) rubber seal.

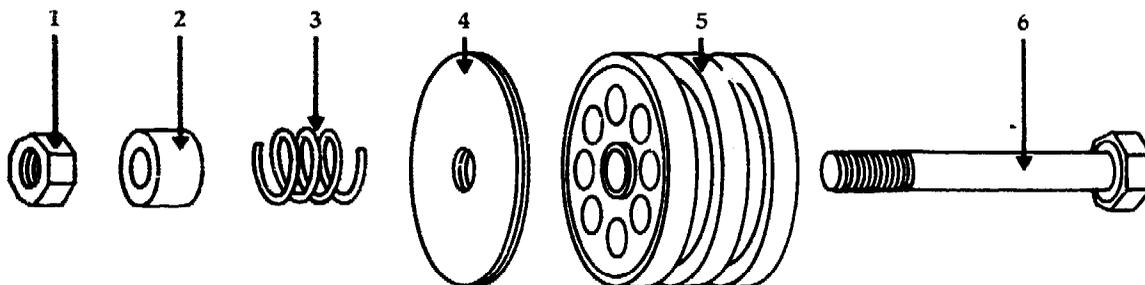
Fig. 2. Modified foot valve: (1) nut; (2) brass valve cap and slip guide; (3) brass spring; (4) flapper valve; (5) PVC valve; and (6) threaded bolt.

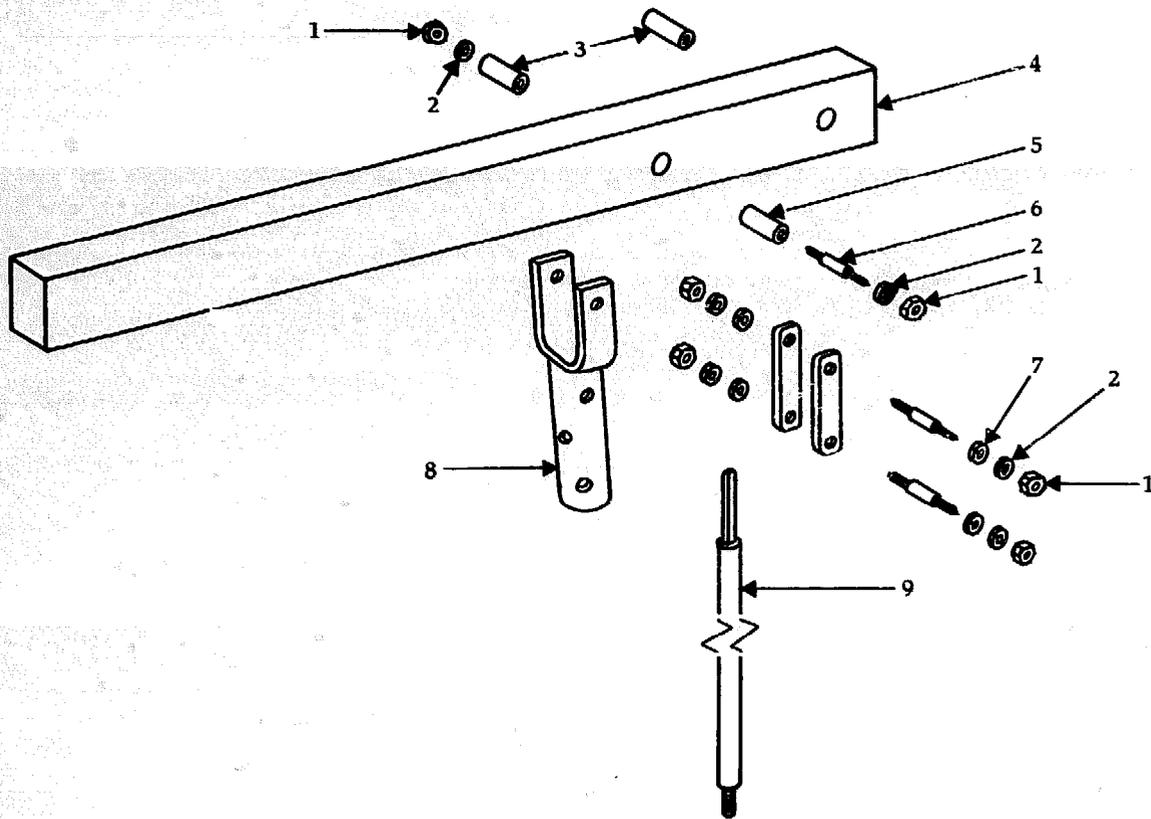
Fig. 3. Modified version of above-ground components: (1) nut; (2) lock washer; (3) brass sleeve bearing; (4) wooden handle; (5) metal sleeve bearing; (6) bolt; (7) washer; (8) handle support pipe; and (9) solid iron rod.

The above-ground components consisted of a wooden handle assembly, metal yoke, a concrete pedestal, and a concrete platform reinforced by 0.5-inch (1.25-cm) steel reinforcement bars. The wooden handle was originally connected to the piston rod by a metal flange. This flange was connected by a bolt to a steel block into which a brass fitting connected to the piston rod was screwed. A problem in the design of this linkage caused the piston rod to buckle during operation. This was remedied by using a solid iron rod for the upper portion of the piston rod (Fig. 3). The pedestal for the pump was

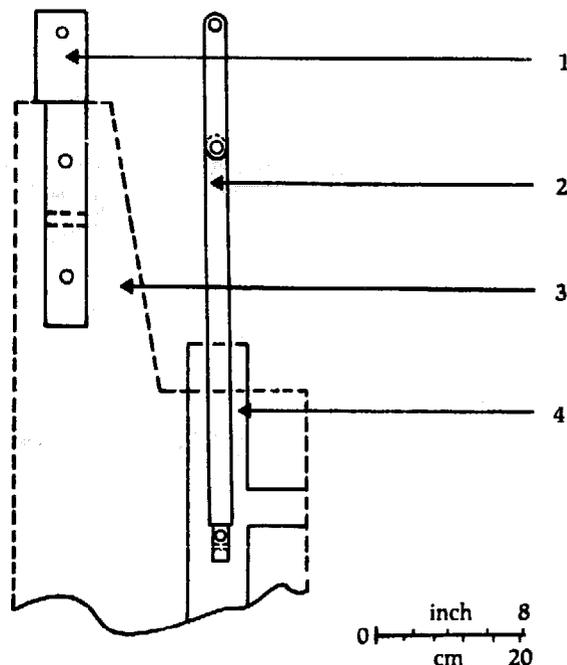
Fig. 4. Details of concrete pump pedestal: (1) handle support pipe; (2) solid iron bar; (3) concrete; and (4) 3-inch (7.5-cm) galvanized pipe.

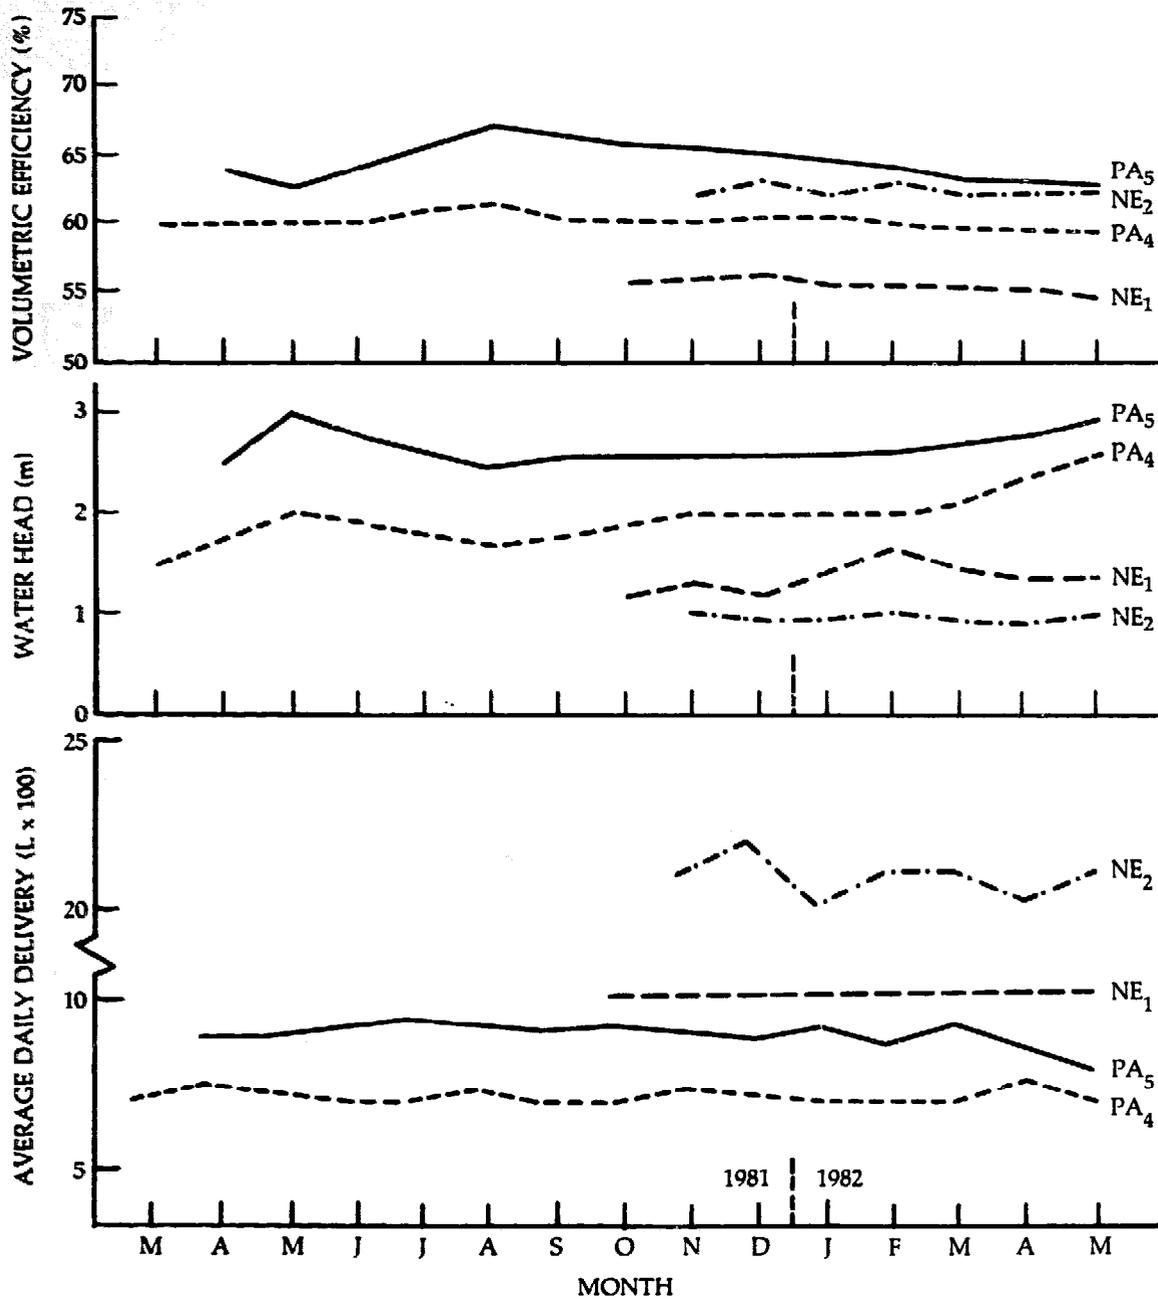
Fig. 5. Volumetric efficiency, average water head, and monthly mean of the average daily delivery of the four pumps during field-testing.

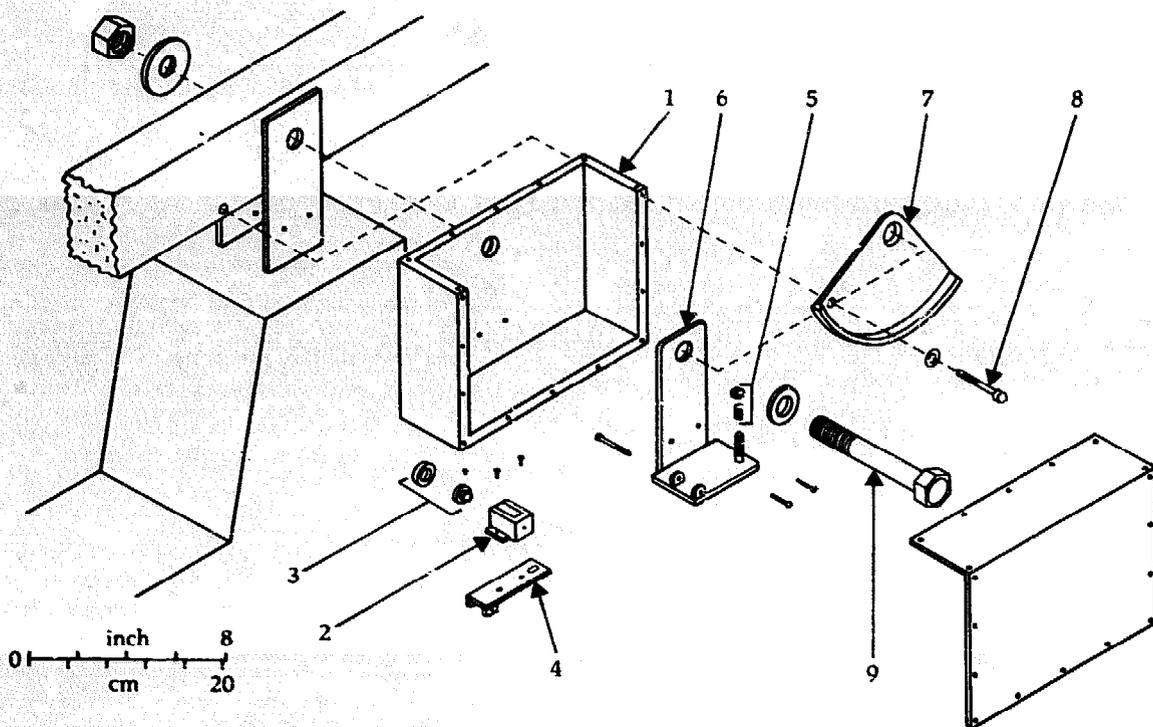
Fig. 6. Design of mount for mechanical counter: (1) housing; (2) counter; (3) counter wheel and rubber ring; (4) counter support; (5) counter adjusting nut and spring; (6) guide assembly; (7) rocker; (8) rocker pin; and (9) pump handle pin.

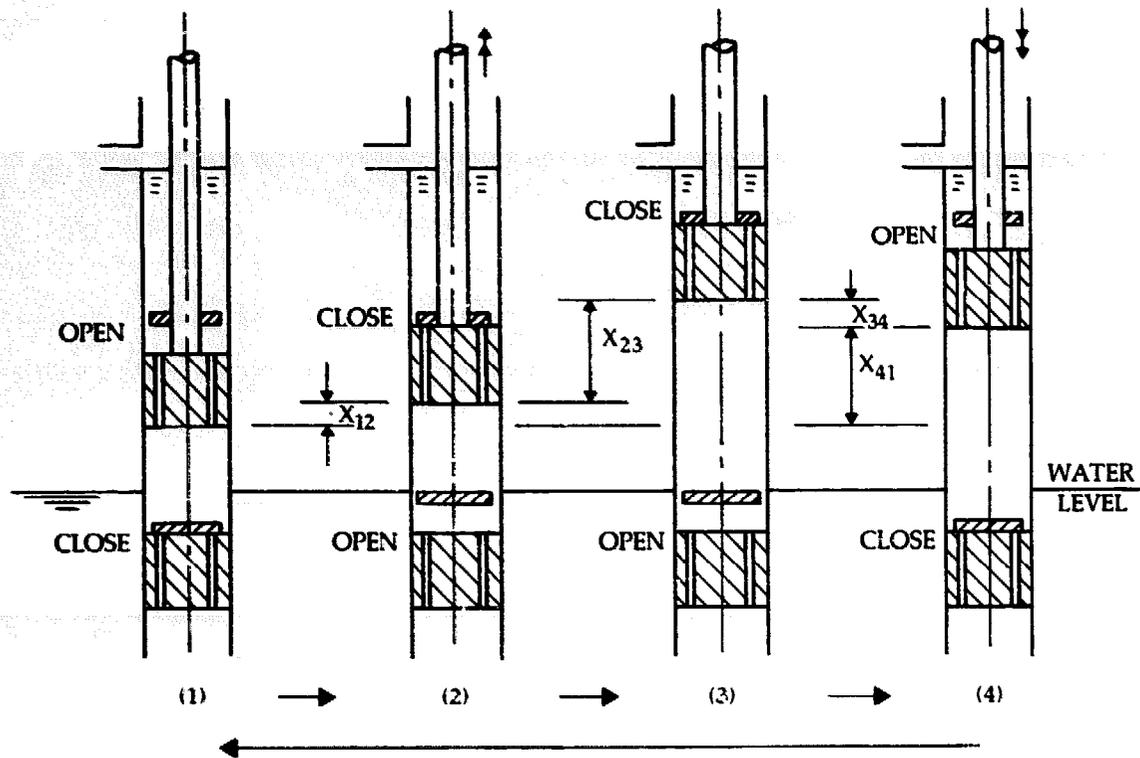
Fig. 1. Cycle of operation of reciprocating piston handpump.

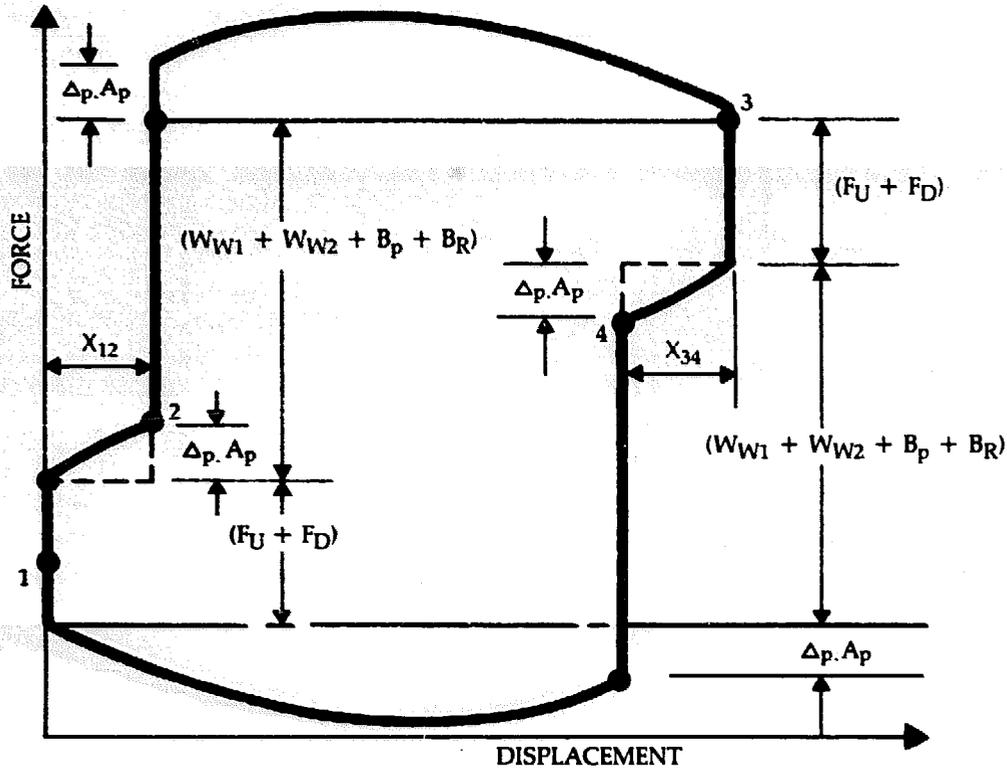
Fig. 2. Force-displacement diagram.
