Village Handpump Technology: Research and Evaluation
in Asia, Publication IDRC-204e

Village Handpump Technology

Research and Evaluation in Asia

Editors: Donald Sharp and Michael Graham

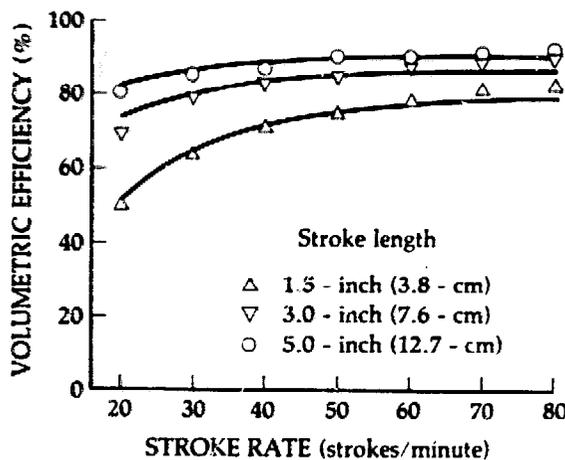
Fig. 3. Variation of volumetric efficiency with speed of stroke application for three stroke lengths (theoretical lines and experimental data points): valve gap, 0.113 inch (2.87 mm); valve weight, 0.029 lb(force) (13.15 g); orifice/piston ratio, 16.4%; and water head, 230 inches (3.66 m).

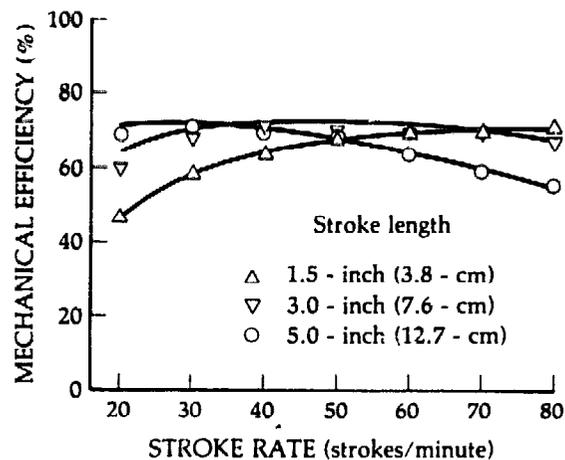
Fig. 4. Variation of mechanical efficiency with speed of stroke application for three stroke lengths (theoretical lines and experimental data points): valve gap, 0.113 inch (2.87 mm); valve weight, 0.029 lb(force) (13.15 g); orifice/piston area ratio, 16.4%; water head, 230 inches (3.66 m).

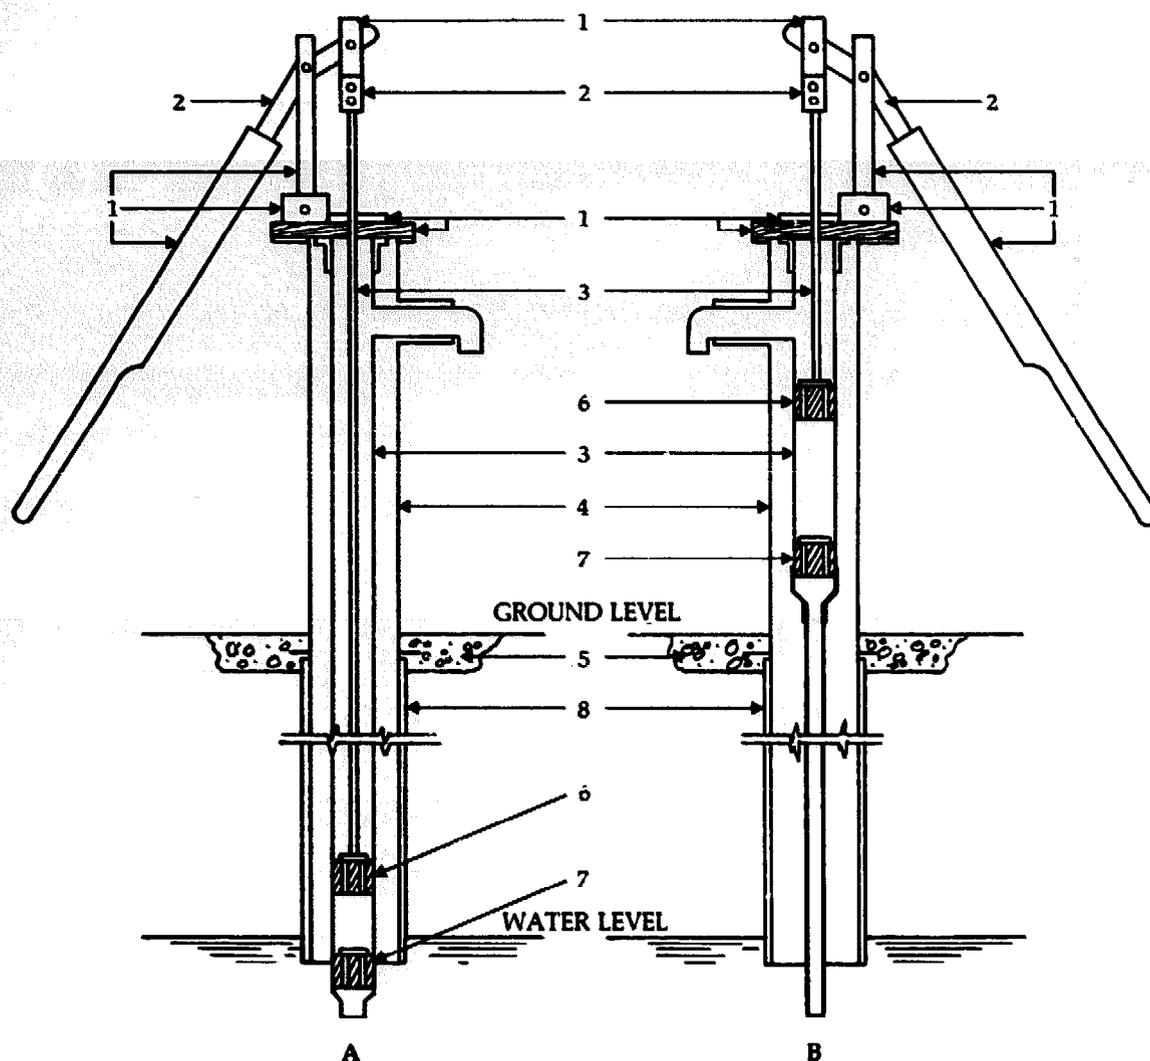
Fig. 5. (A) Lift and (B) suction pumps: (1) wooden parts; (2) galvanized parts; (3) PVC parts; (4) mild-steel stand; (5) concrete; (6) piston; (7) foot valve; and (8) casing pipe.

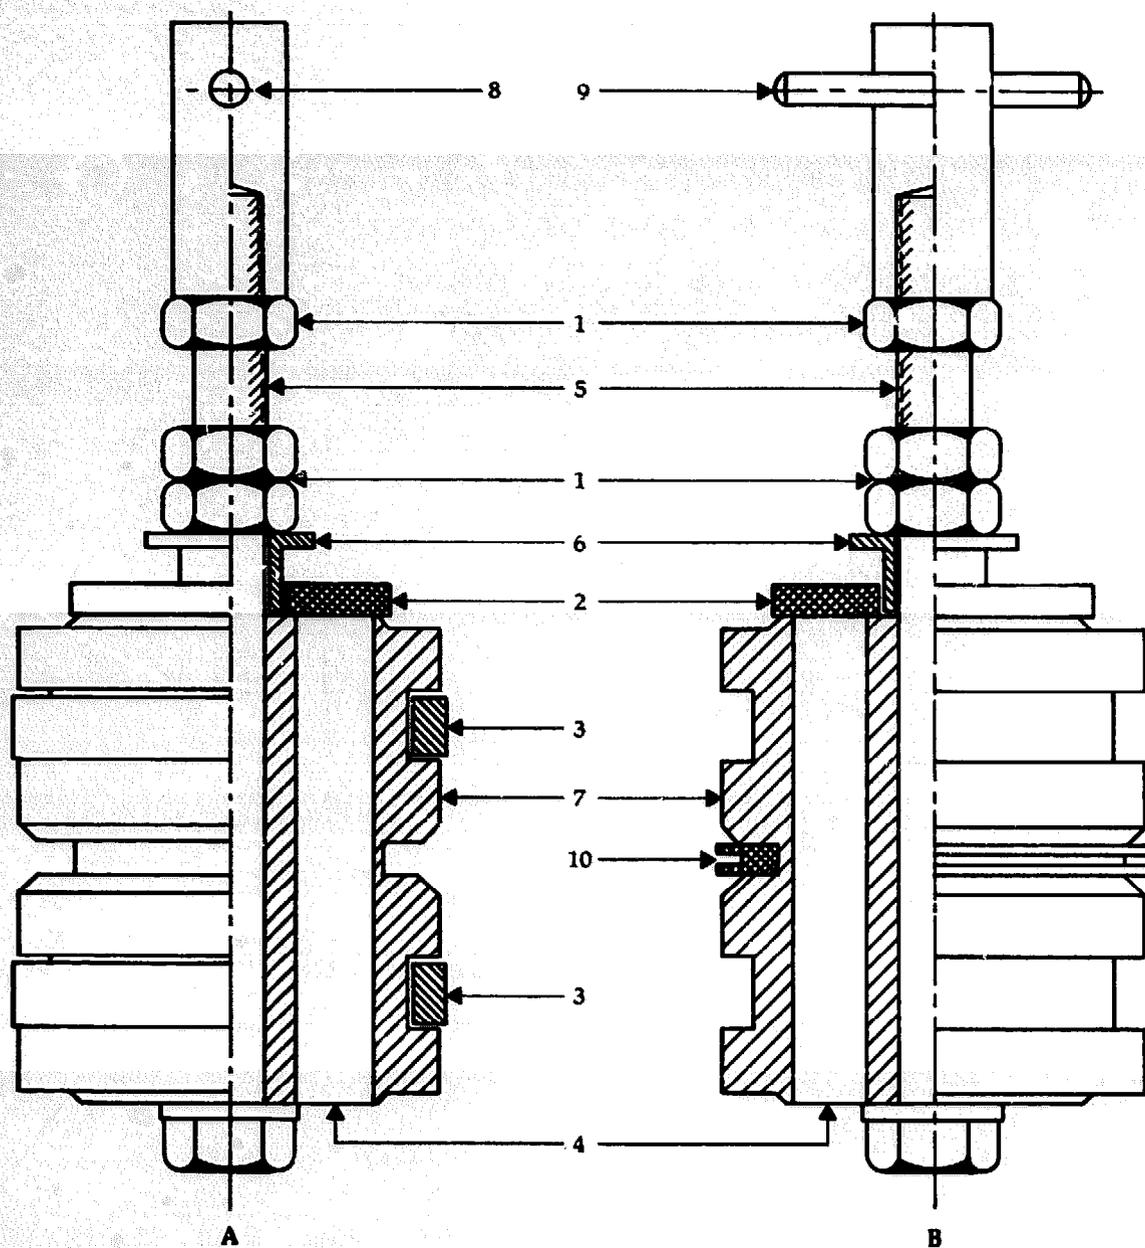
Fig. 6. (A) Piston assembly and (B) recoverable foot valve: (1) lock nuts; (2) valve flap (natural rubber); (3) piston rings (polyethylene); (4) six equally spaced holes; (5) bolt; (6) valve stop; (7) PVC plastic; (8) hole for connecting pin; (9) recovery pin; and (10) double-lip rubber seal.

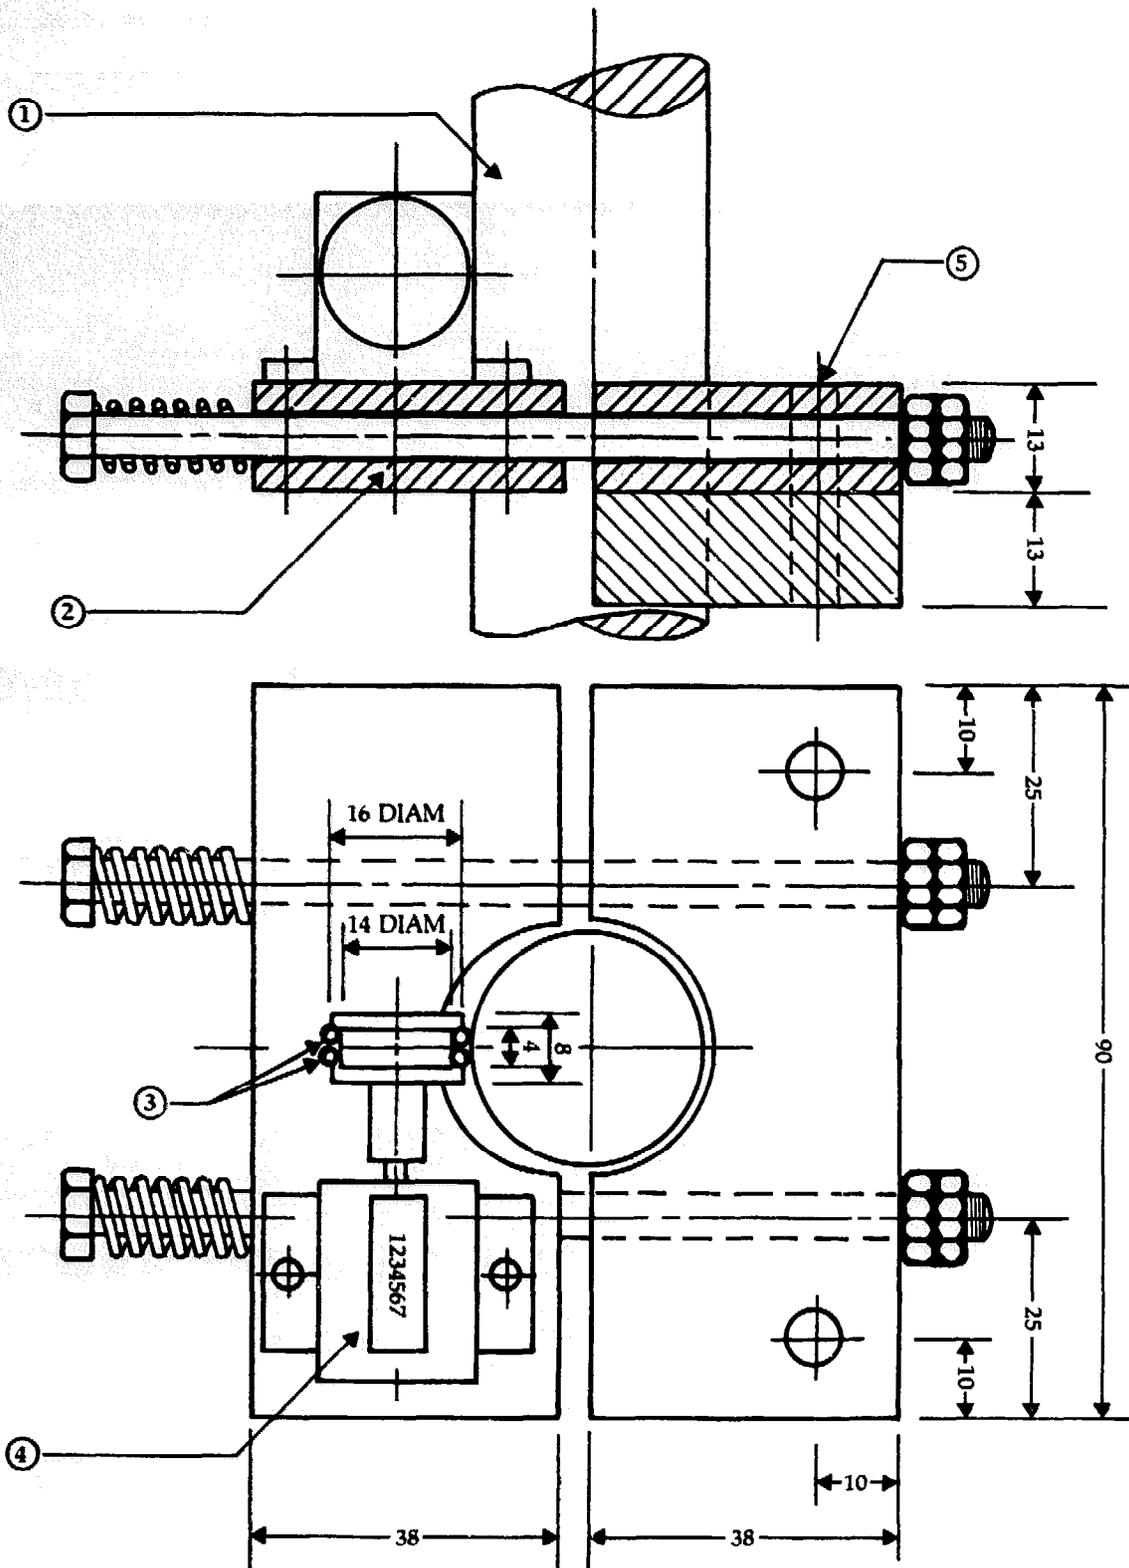
Fig. 7. Mounting for Veeder-Root (V-R) counter on handpumps (all dimensions in mm; 10 mm = 0.3937 inch): (1) piston rod; (2) sliding fit to allow for lateral movement of counter; (3) two O-rings (13 mm ID x 2 mm diam (0.51 x 0.08 inch) cross-section); (4) V-R flange-case counter (#74-6125-001); and (5) mounting screw to top plate of handpump.

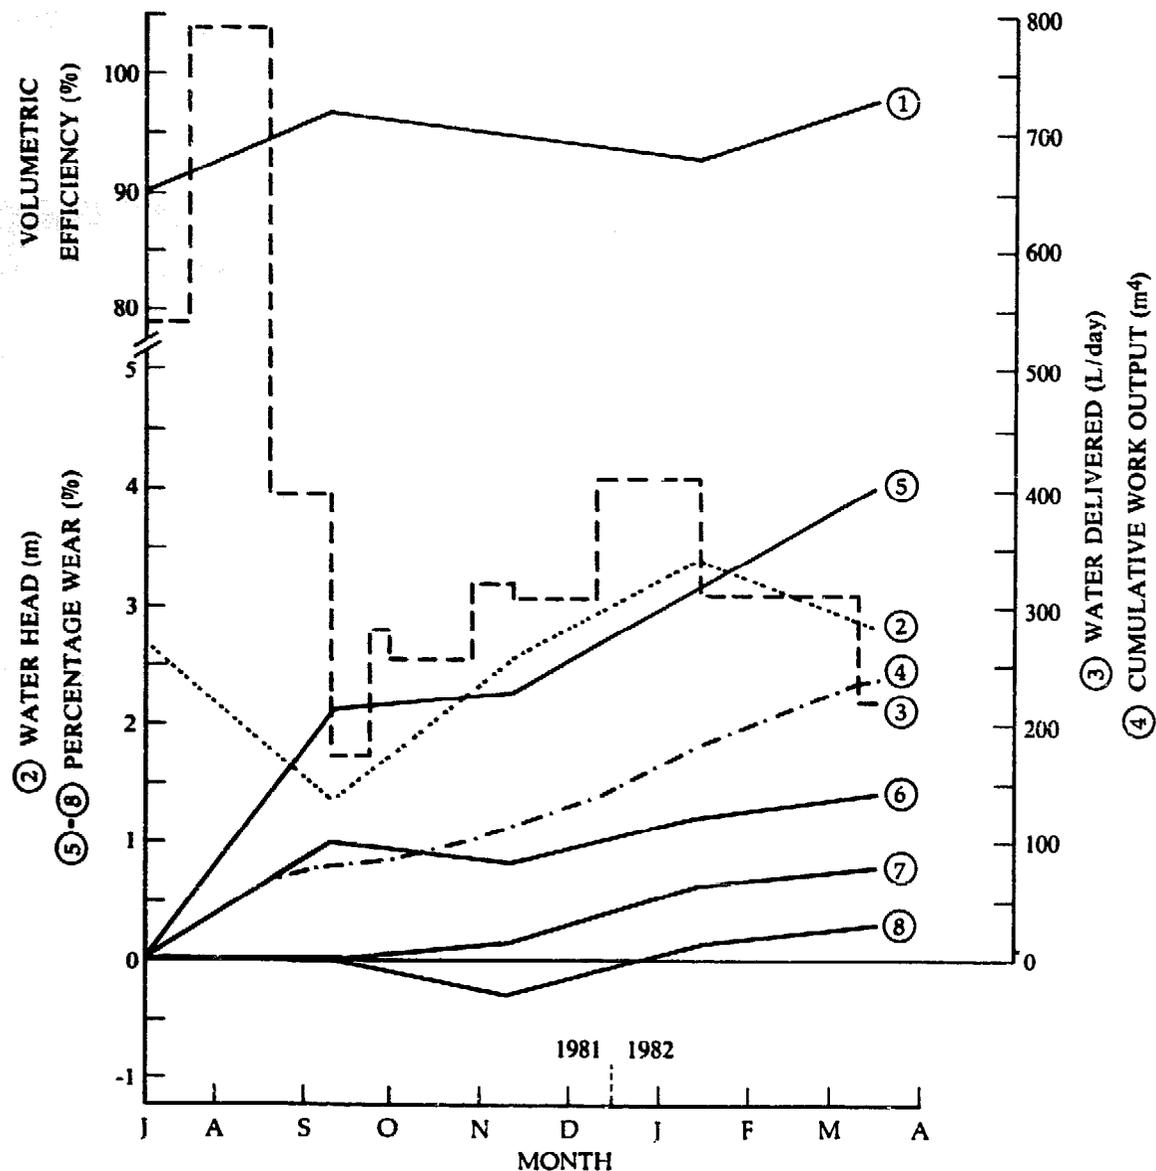
Fig. 8. Performance characteristics of handpump PK 001S in field test: (1) volumetric efficiency; (2) water head; (3) water delivered per day; (4) cumulative (total) work output ($m^4 = m^3$ (volume) \times m (lift)); (5) percentage wear of top wooden bushing (0°); (6) percentage wear of bottom wooden bushing (90°); (7) percentage wear of top piston ring; and (8) percentage wear of bottom piston ring.

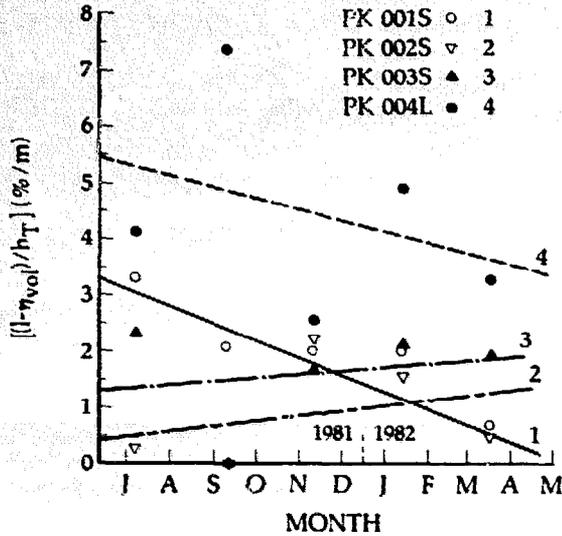
Fig. 9. Variation of $[(1 - \eta_{vol}) / h_T]$ with calendar time for four pumps.

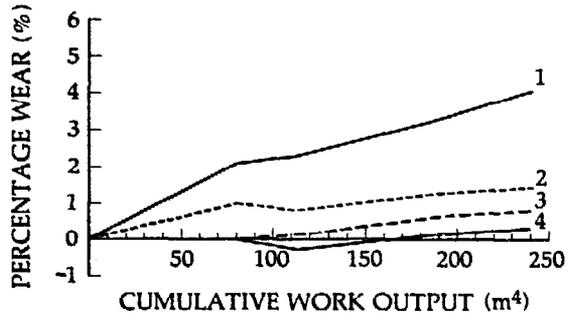
Fig. 10. Variation of wear with cumulative (total) work output for handpump PK 001S: (1) top wooden bushing (0°); (2) bottom wooden bushing (90°); (3) top piston ring; and (4) bottom piston ring.

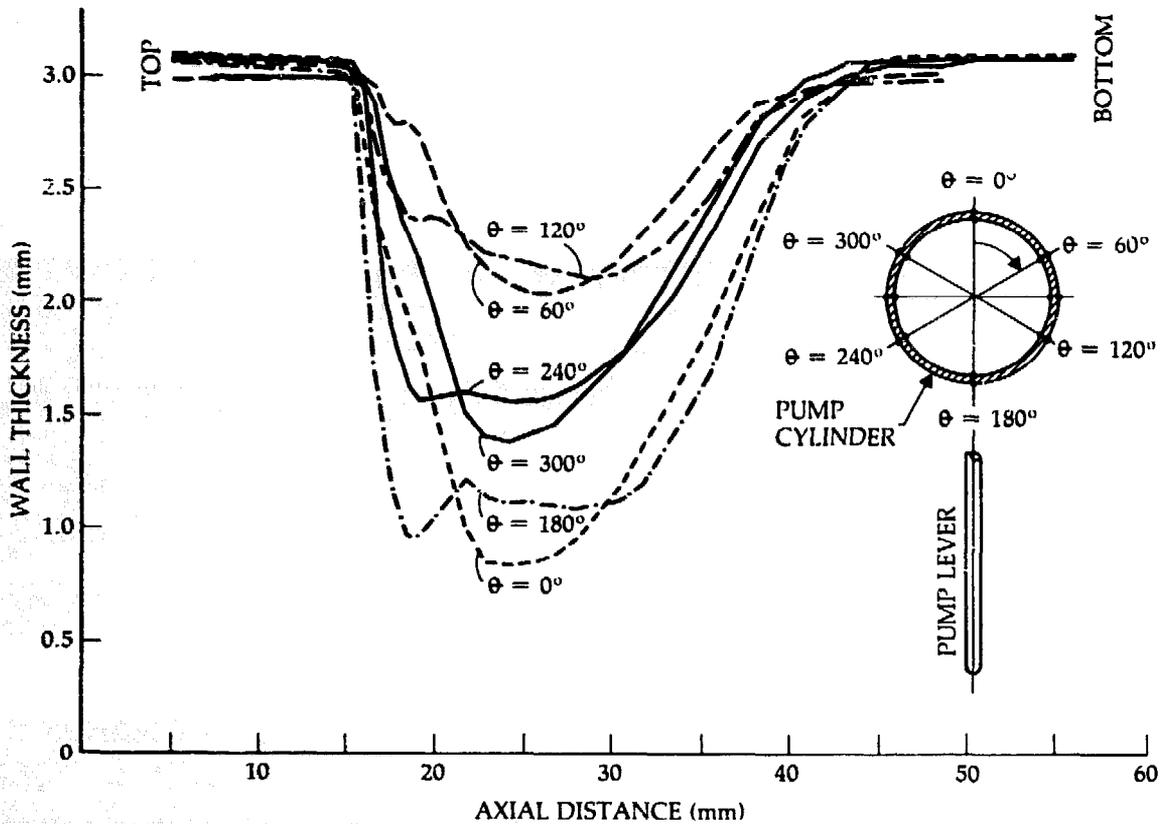
Fig. 11. Variation of wall thickness of pump cylinder with axial distance for pump NS 010S.

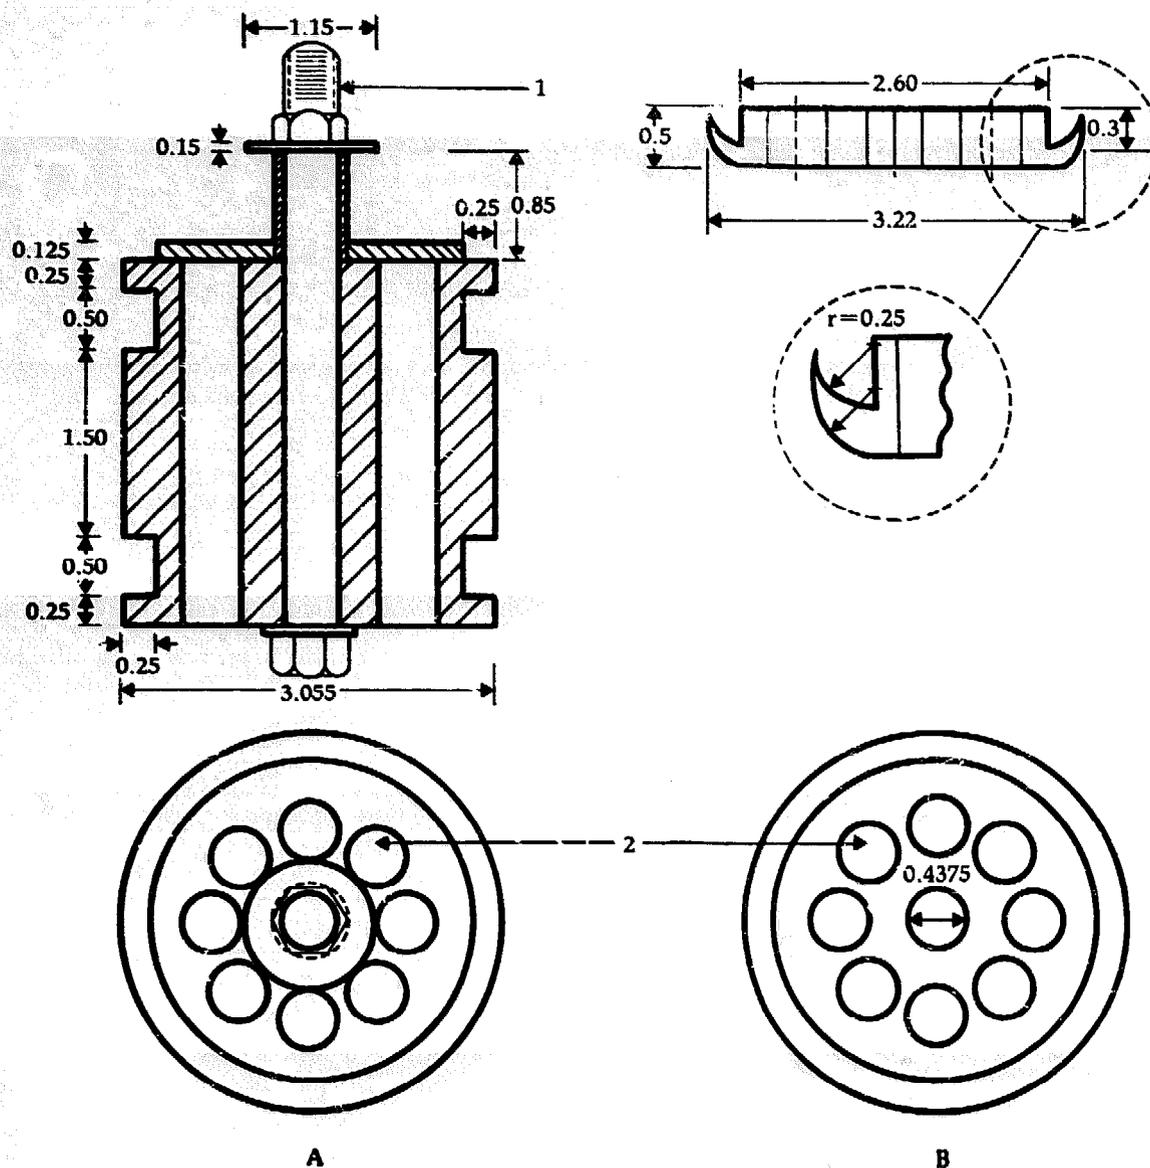
Fig. 1. Design of original (A) piston and (B) foot-valve adaptor tested in the Asian handpump network (all dimensions in inches; 1 inch = 25.4 mm): (1) 7/16-inch (1.11-cm) diameter bolt, 5.5 inches (13.97 cm) long; (2) 0.5-inch (1.27-cm) holes at 1.53-inch (3.89-cm) pitch diameter.

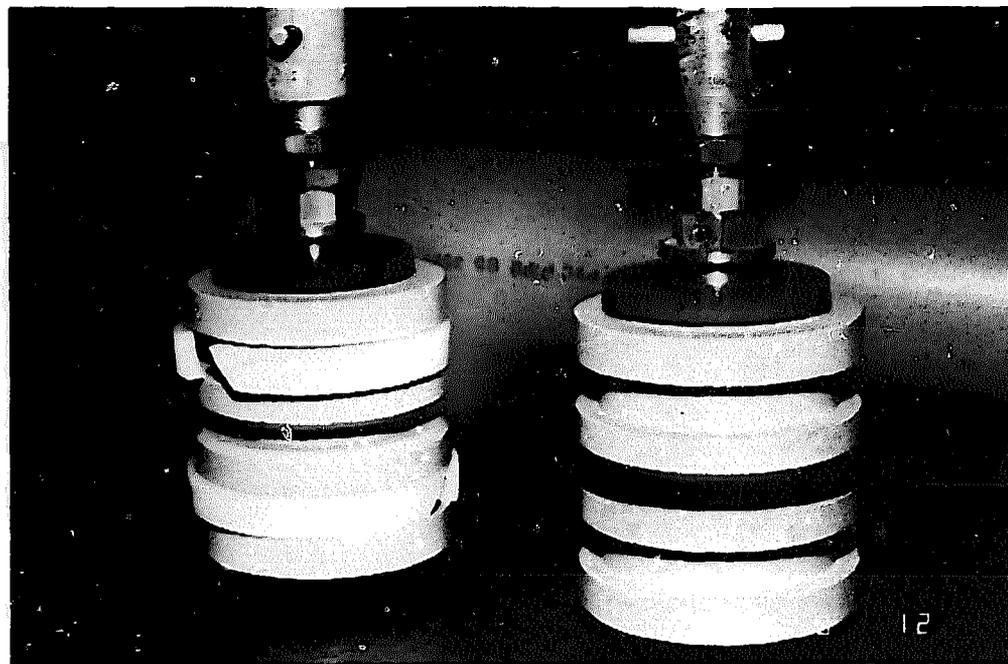
The Waterloo piston (left) and foot valve (right) are moulded from solid PVC. Except for the piston rings and the rubber seal on the foot valve, they are interchangeable.
