Laboratory Testing of Handpumps for Developing Countries,
World Bank Technical Paper #19 from the Rural Water
Supply Handpumps Project

Rural Water Supply Handpumps Project

Laboratory Testing of Handpumps for Developing Countries: Final Technical Report

Consumers' Association Testing and Research Laboratories

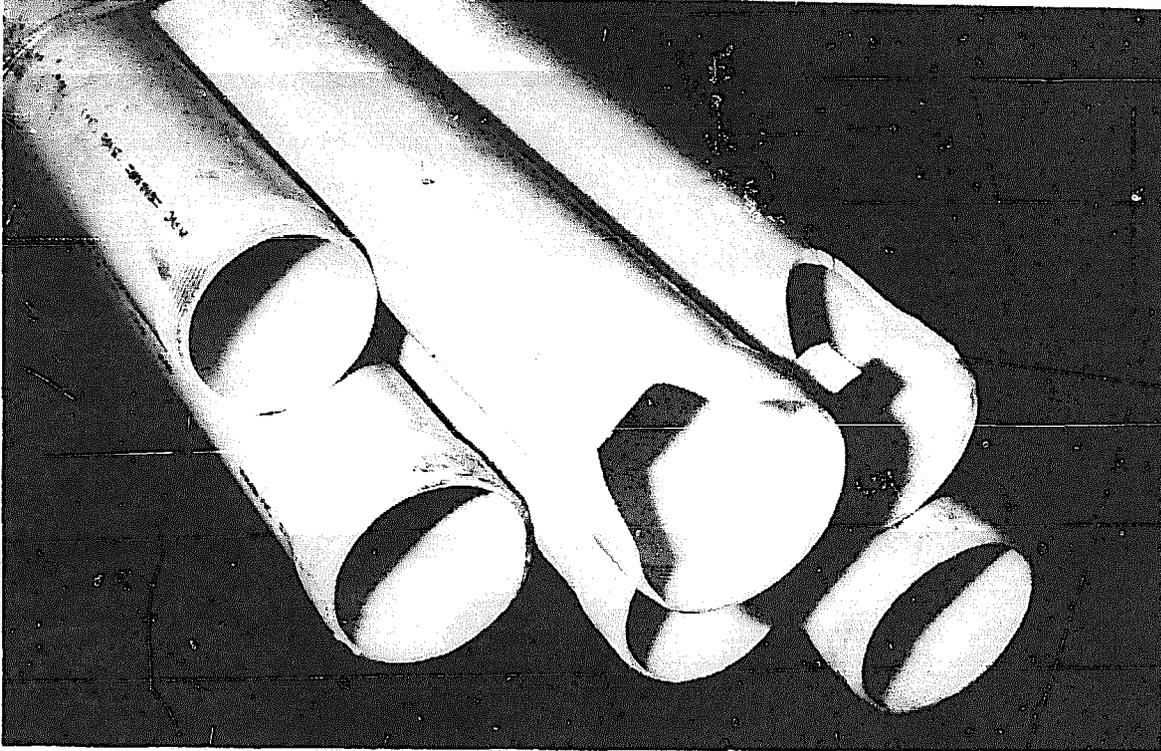
Inadequate Packaging in Cardboard Boxes

Broken Pipes

The centre bolts were missing from the pumpstand cross braces. One crank arm was bent in transit. One handle was bent. The standard of welding was poor on the flanges of the T-pieces of both samples. The galvanising was poor inside the spout units. Plastic parts of some pipe fittings were broken in transit and the ends on some pipe sections were also damaged.

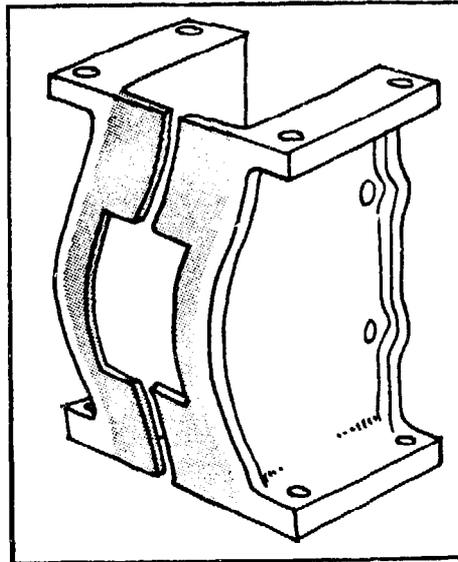
The quadrant and rack present a safety hazard and should be shrouded. This may be achieved by modifying the casting patterns for the pumpstand side plates as shown, right.

In response, the manufacturer has modified the pumpstand by adding a cover plate shielding the quadrant from above, and by reducing the lift of the plunger valve. The cover plate provides a good deal of protection but can easily be removed and left off. The suggested change to the casting is therefore preferable.

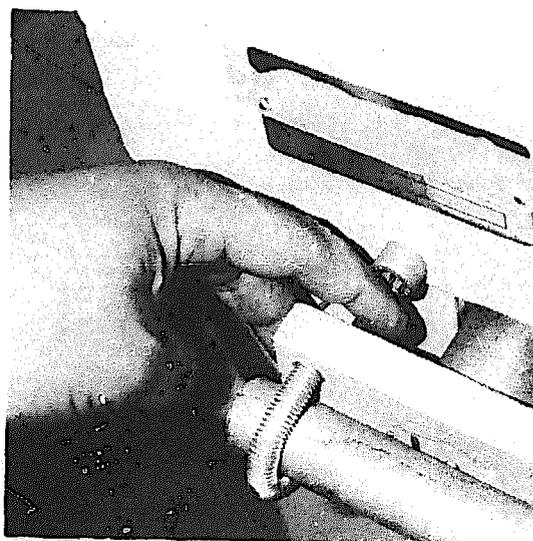
There are a number of potential finger traps between the handle and the pumpstand, see photograph. Increased clearances would help considerably.

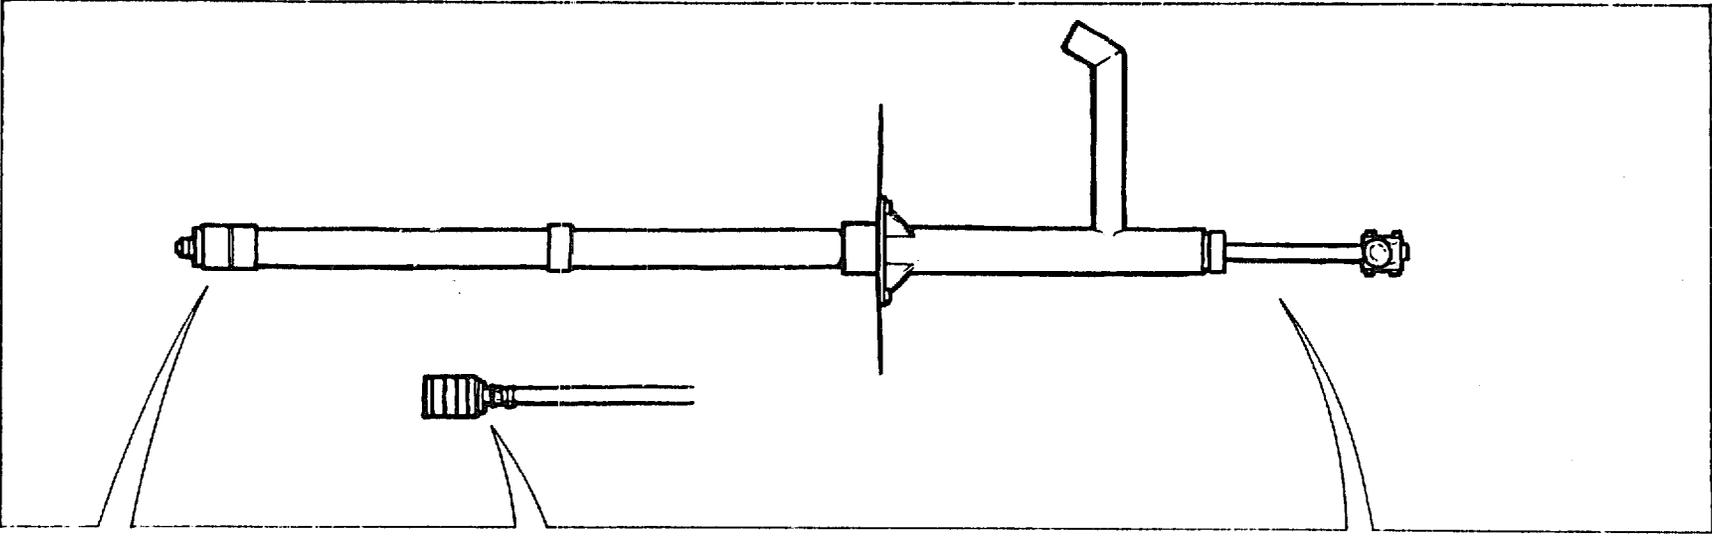
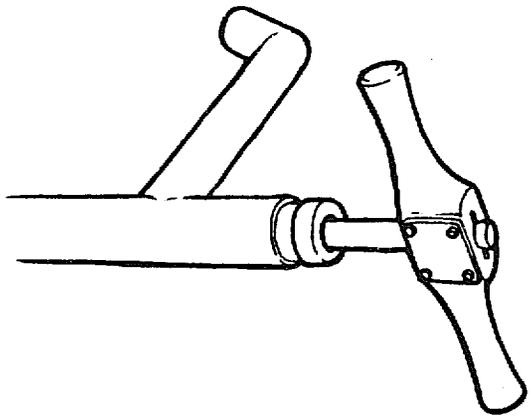
ETHIOPIA TYPE BP50

In the final inspection, most parts of the plunger were clearly worn, particularly those parts forming the valve. Although still operating, the performance had fallen off considerably. The piston diameter had worn by 0.3mm or so, and the cylinder by about 1mm on diameter. Particles of sand were embedded in the HDPE plunger. In actual use the wear in the rising main could be compensated by altering the position of the plunger in the rising main. The pump rod bush in the pumpstand was worn, but this did not affect the performance.

- 1. Pumpstand Top bush worn but otherwise in good condition
- 2. Rising Main Bore worn approximately 1 mm on diameter throughout swept area - many scratches from sand particles embedded in plunger
- 3. Plunger (a) Worn approximately 0.3 mm on diameter
(b) Many sand particles embedded in plunger
(c) Plunger valve washer, sleeve and centre bolt all badly worn
(d) Bolt hole through plunger noticeably worn
- 4. Check Valve Hole in steel washer worn, but serviceable
- 5. Corrosion Noticeable corrosion of ferrous parts in both plunger and foot valve.

Wear in the plunger and rising main, and hence increase in diametral clearance, has resulted in a marked reduction in volume flow, and consequently in efficiency, particularly at low operating speeds.

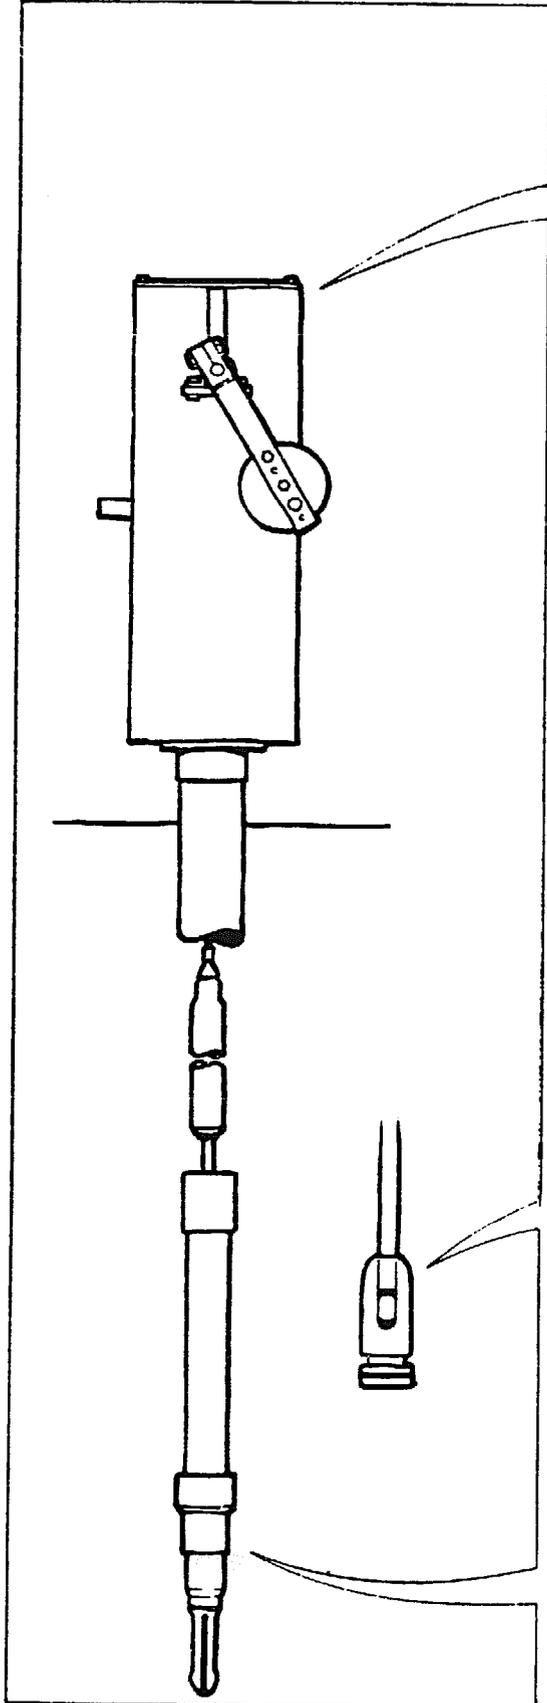
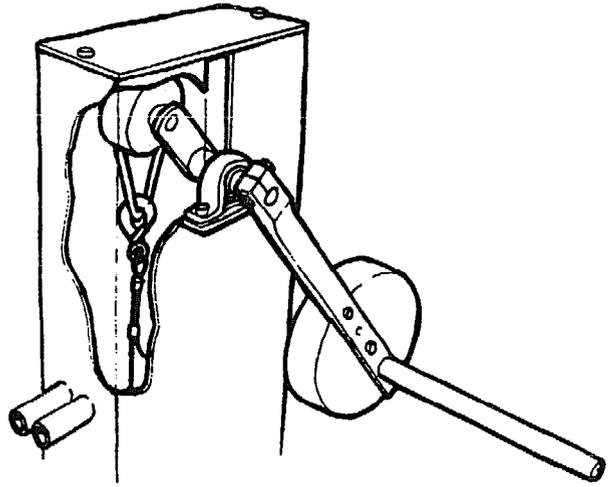
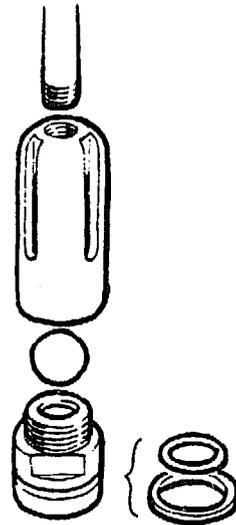
VEW A 18

The pump was tested at 40 revolutions per minute at a simulated head of 45 metres and failed after only 152 hours. The tendency of the operating cable to twist under tension had made the bearing saddle run out of true, causing rapid wear of the saddle and the crankshaft. Both were replaced, and a swivel was fitted in the cable. The handle broke at 277 hours, and the replacement bearing saddle and crankshaft were worn out after 598 hours.

In the final inspection, the plunger seal was found to be worn out, the plunger body was worn and also the plunger rod where it passed through the cylinder top. The cylinder bore was in good condition. There was some play in the big end but in all other respects the pumpstand was in good condition.

- (a) Changing the crankshaft plunger blocks to a heavier pattern and redesigning the crankshaft 'big end' assembly.
- (b) Changing the cable to the type designed for hoists and lifts, which will not twist under tension.
- (c) Supplying polished solid handles.
- (d) Attaching the handles more securely to the ends of the crankshaft and repositioning the counterweights.
- (e) Making the cylinder easier to dismantle, to replace the plunger seals.
- (f) Single rigid spout, with slots to prevent faecal contamination.

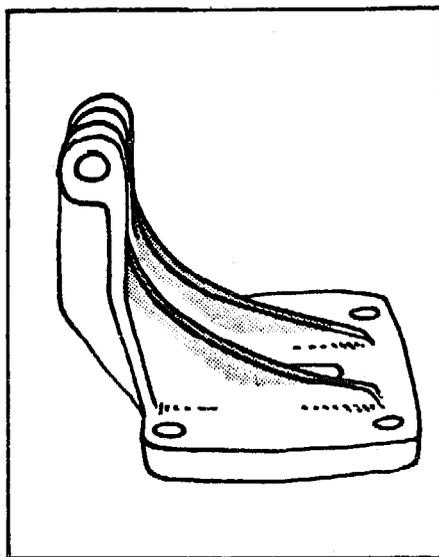
The webs on the cylinder top casting should be extended to make it more robust - see illustration.

The design of the plunger should be improved to control the compression of the cup washer, to reduce the tendency of the rubber to extrude outwards.

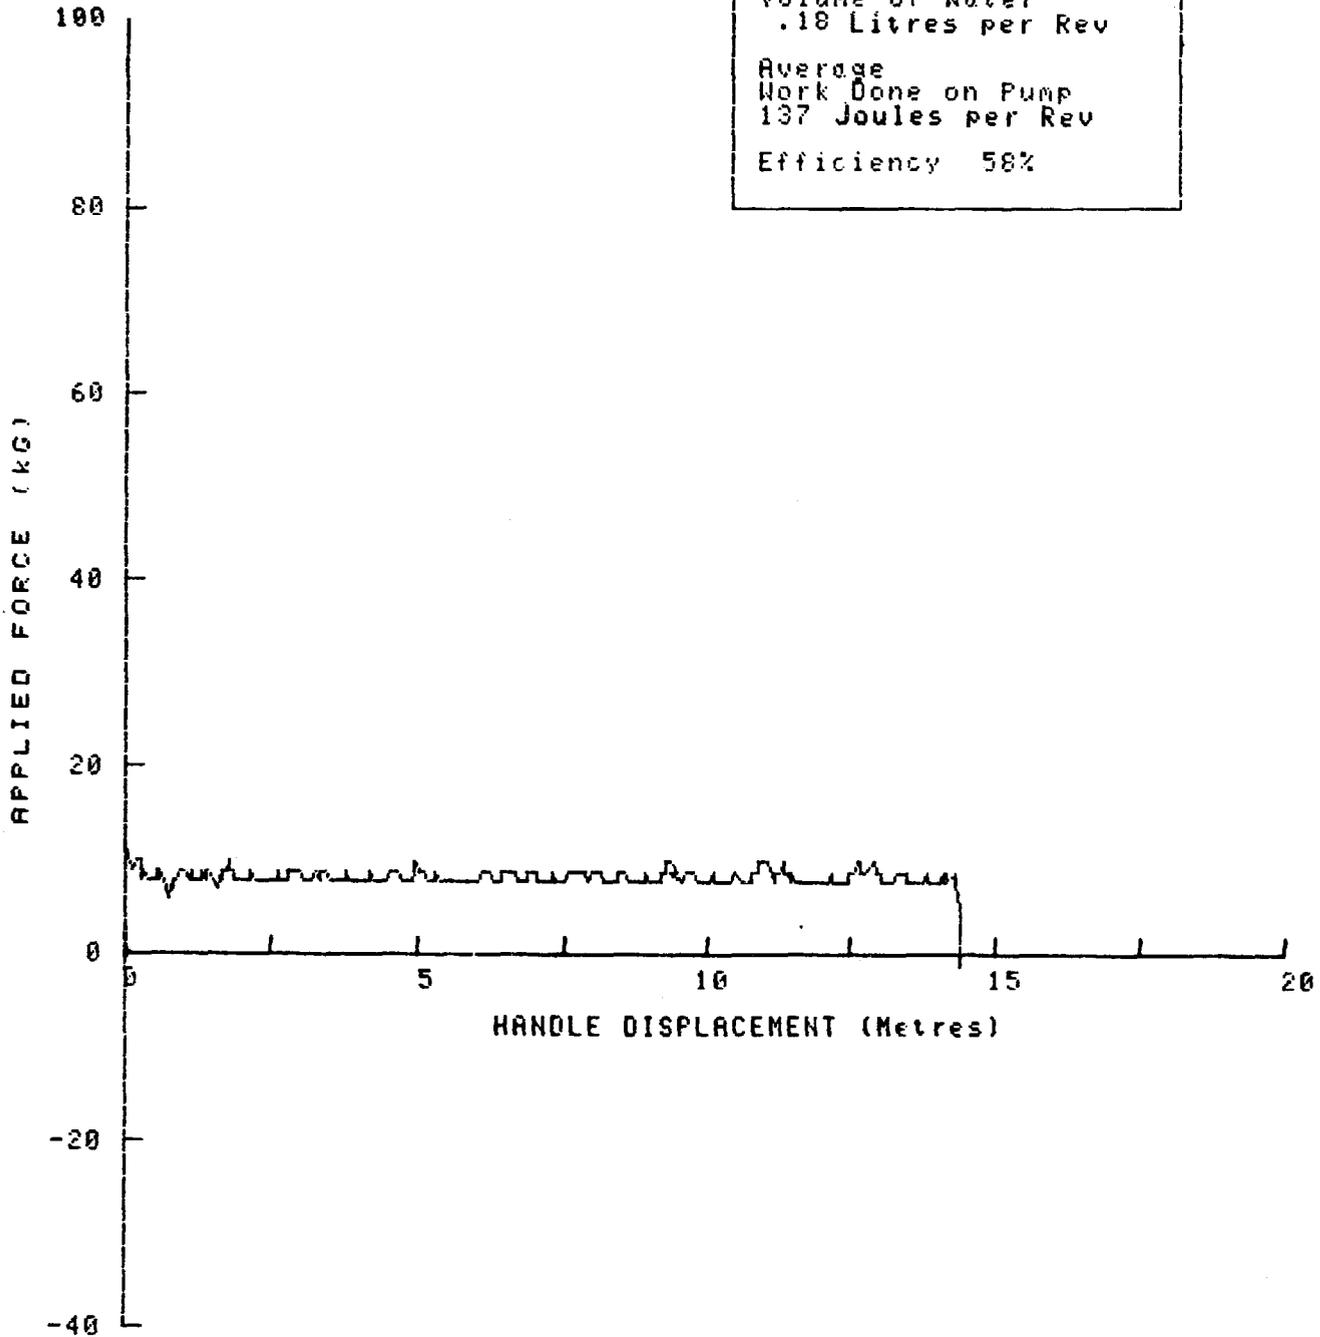
The irregularities on the power stroke are probably caused by variations in the linkage friction due to the wear which has taken place in the linkage mechanism.

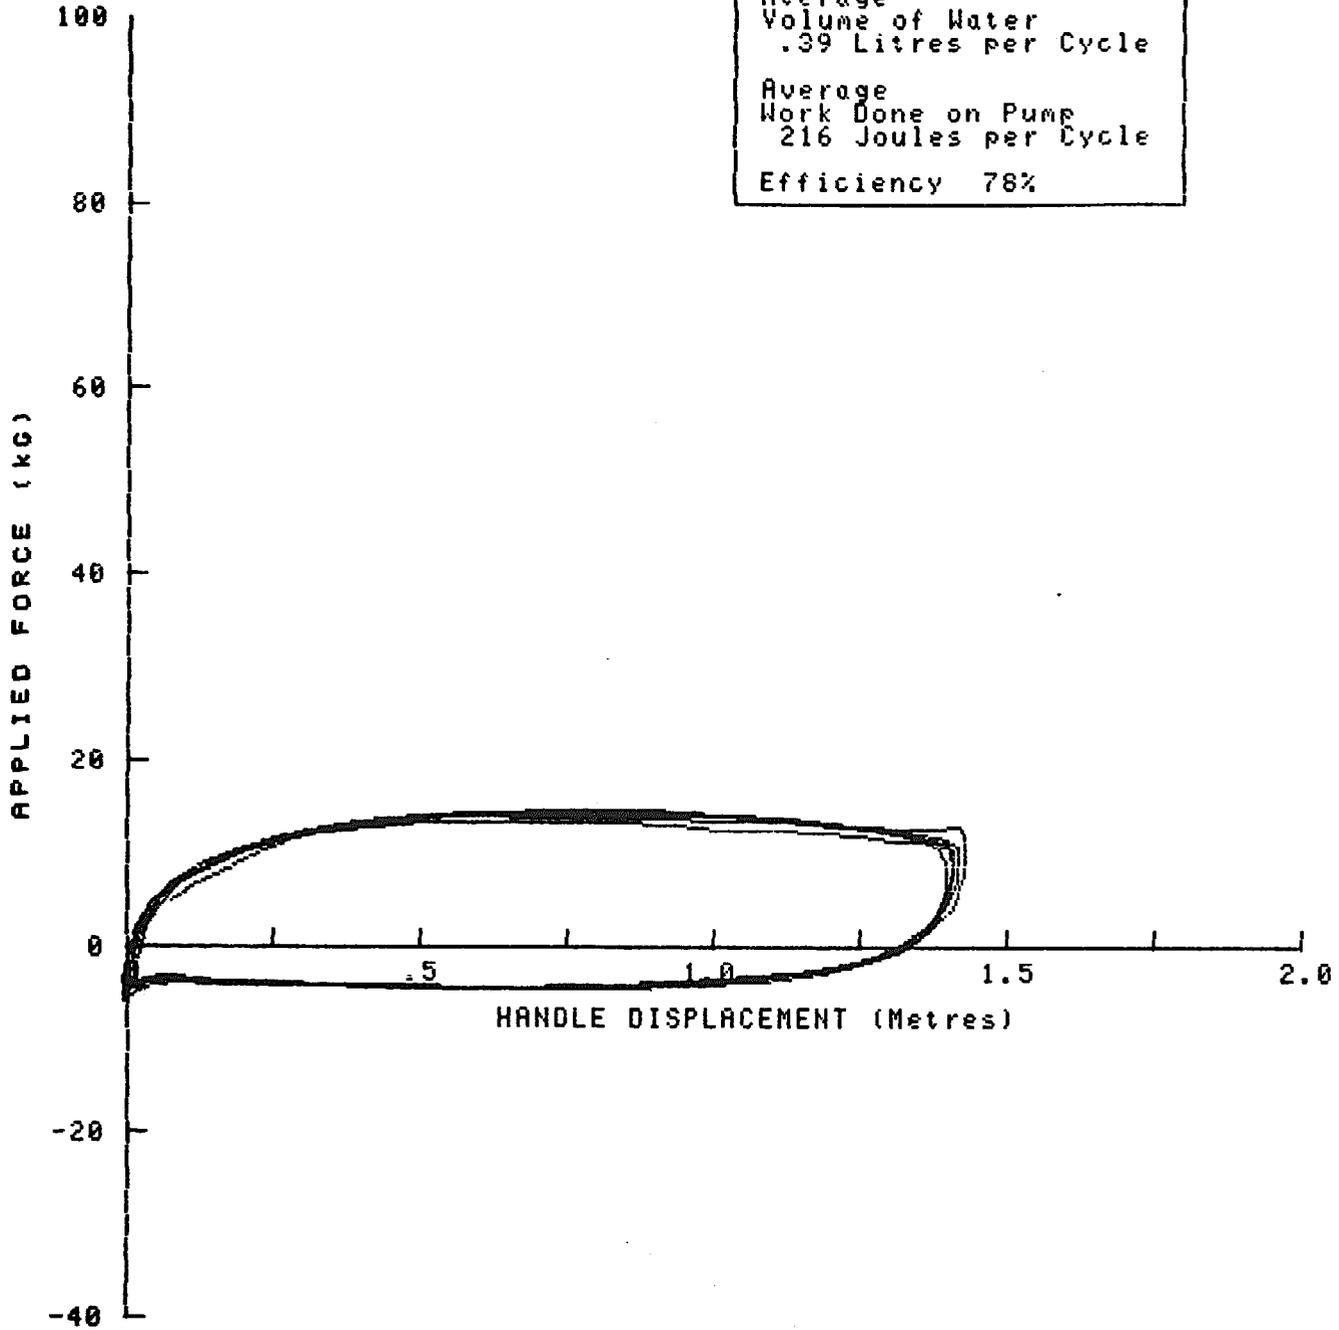
The irregularities on the curves are probably due to system noise.

The diagrams indicate a reduction of friction combined with an increase in volume flow.

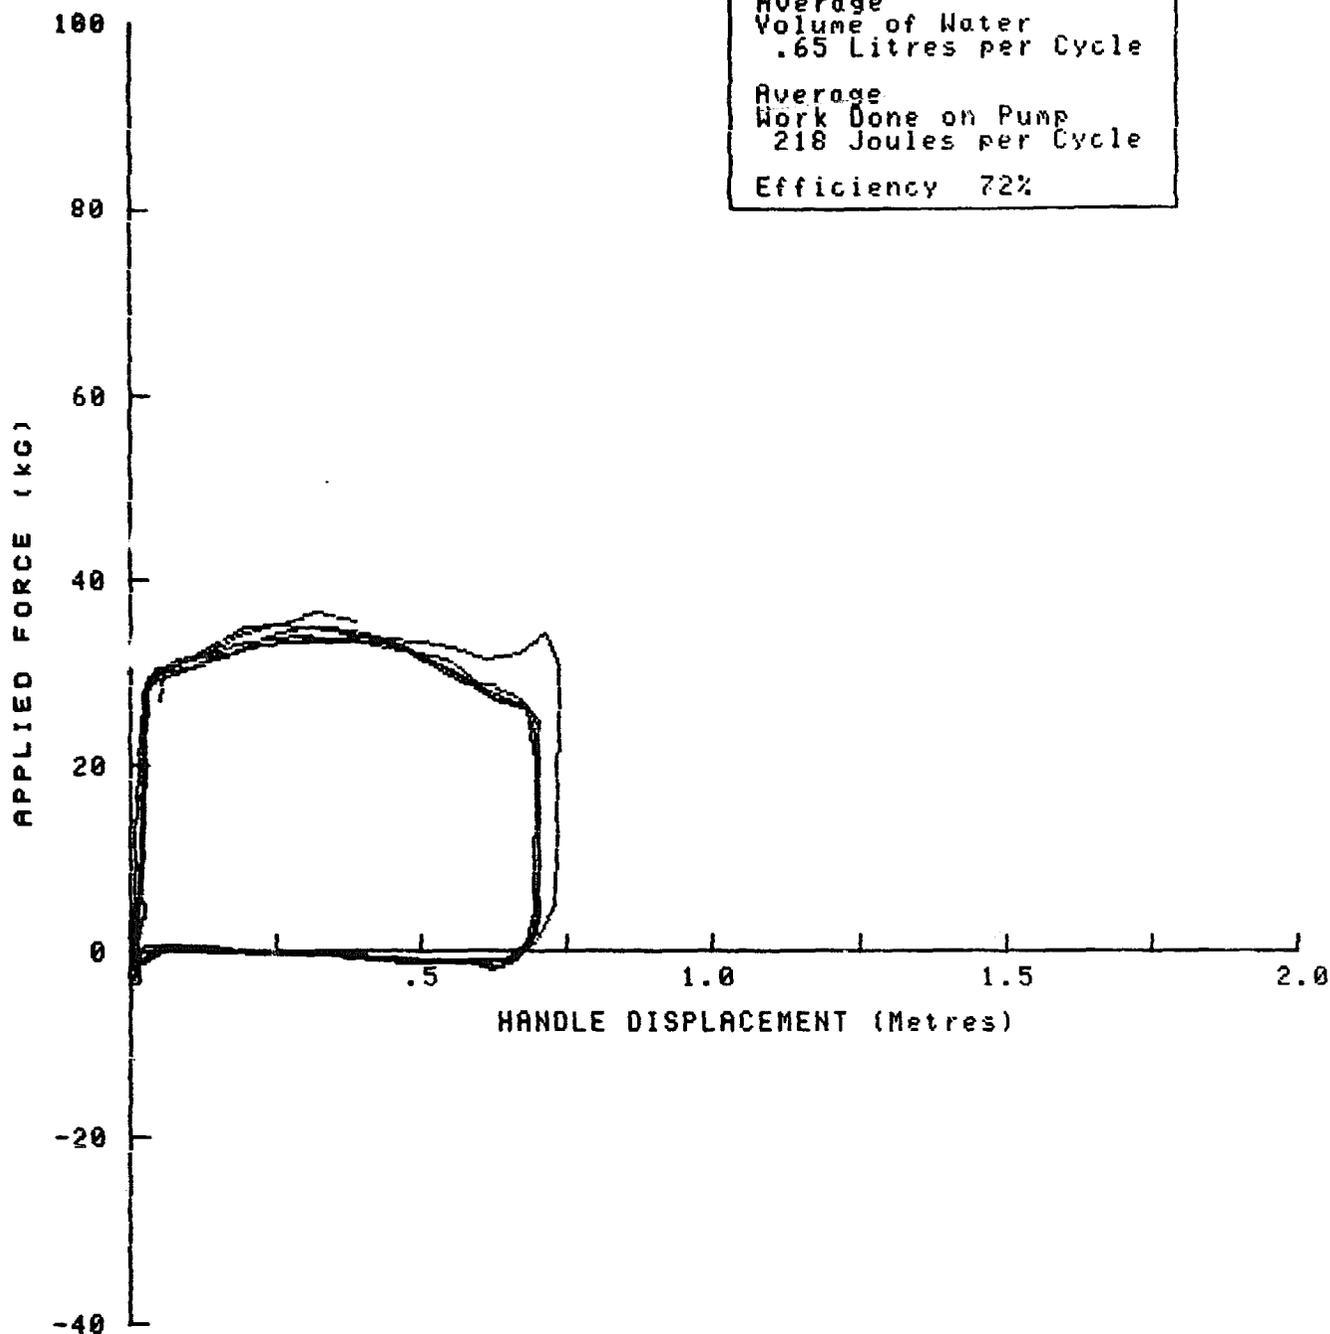
PUMP PERFORMANCE after endurance CODE G Nira AF76

Differences in the profiles of the curves at the beginning of the delivery stroke, and the reduction of effort on the return stroke, probably illustrate the improved conformity of the rubber cup washer after bedding in.

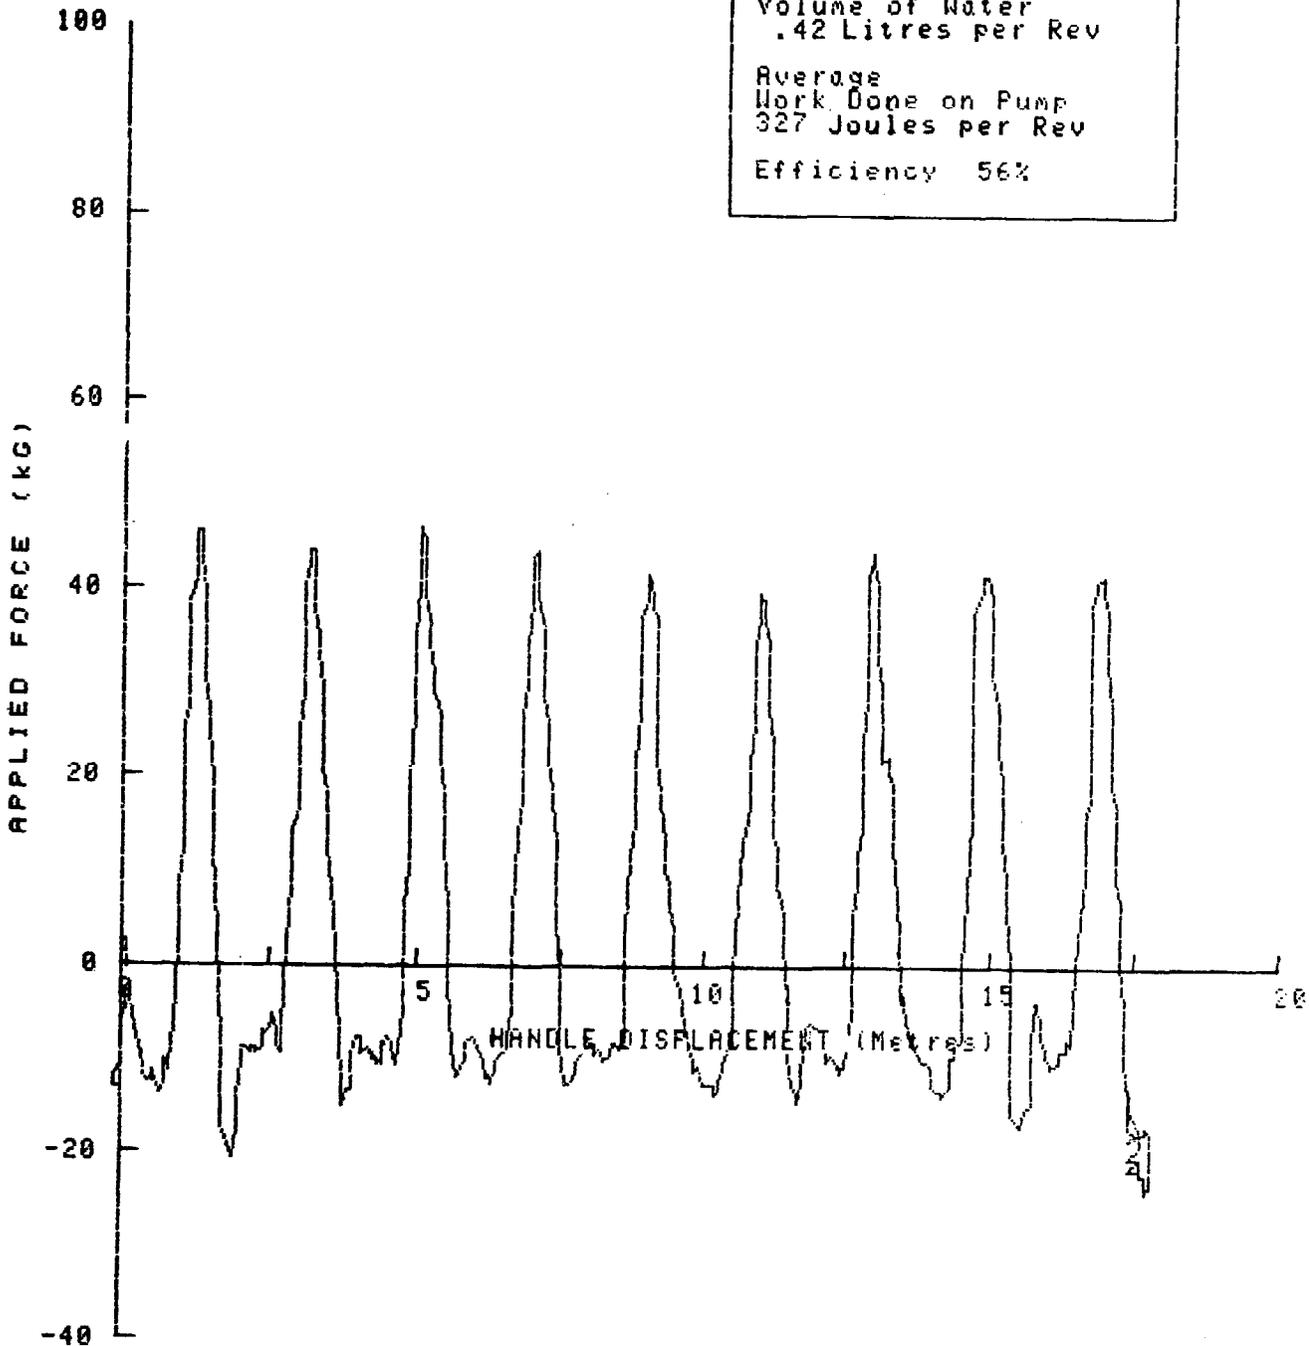
PUMP PERFORMANCE after ENDURANCE CODE J VEW A18

The results before and after endurance should not be directly compared because the plunger seal was replaced during the endurance test. Differences in the profiles of the curves may also reflect the changed position of the handle counterweights.

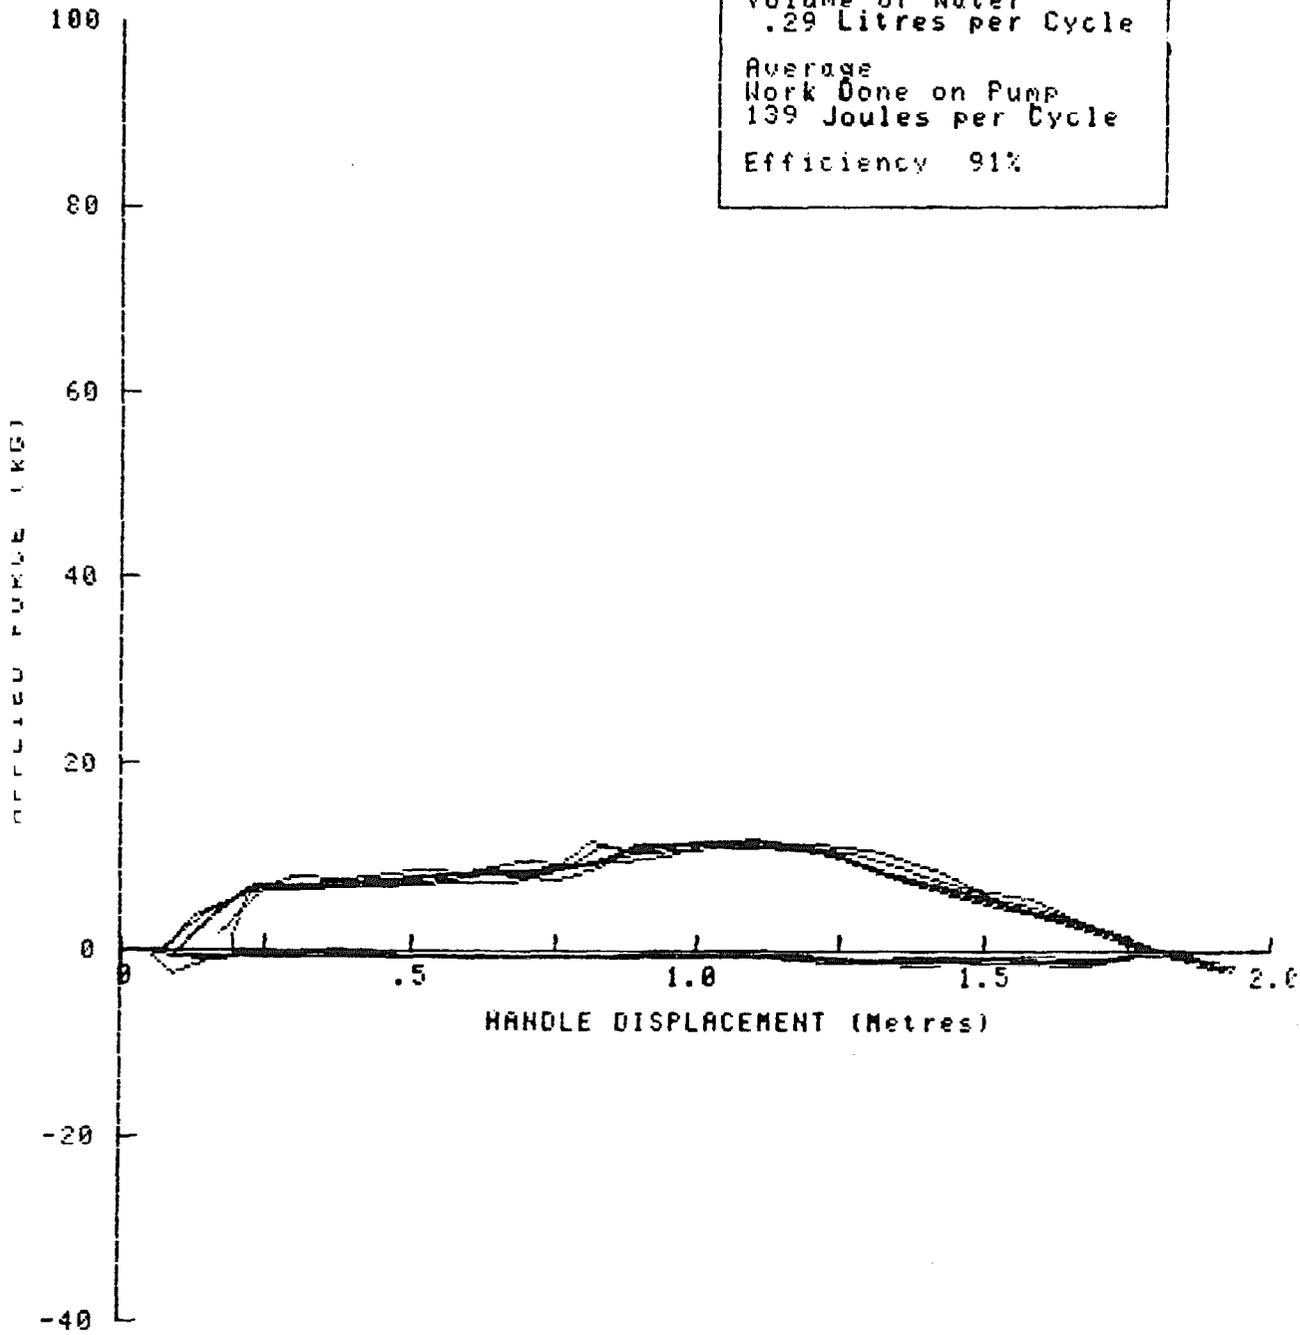
PUMP PERFORMANCE after ENDURANCE CODE K Jetmatic

The results illustrate reduced friction after endurance testing.

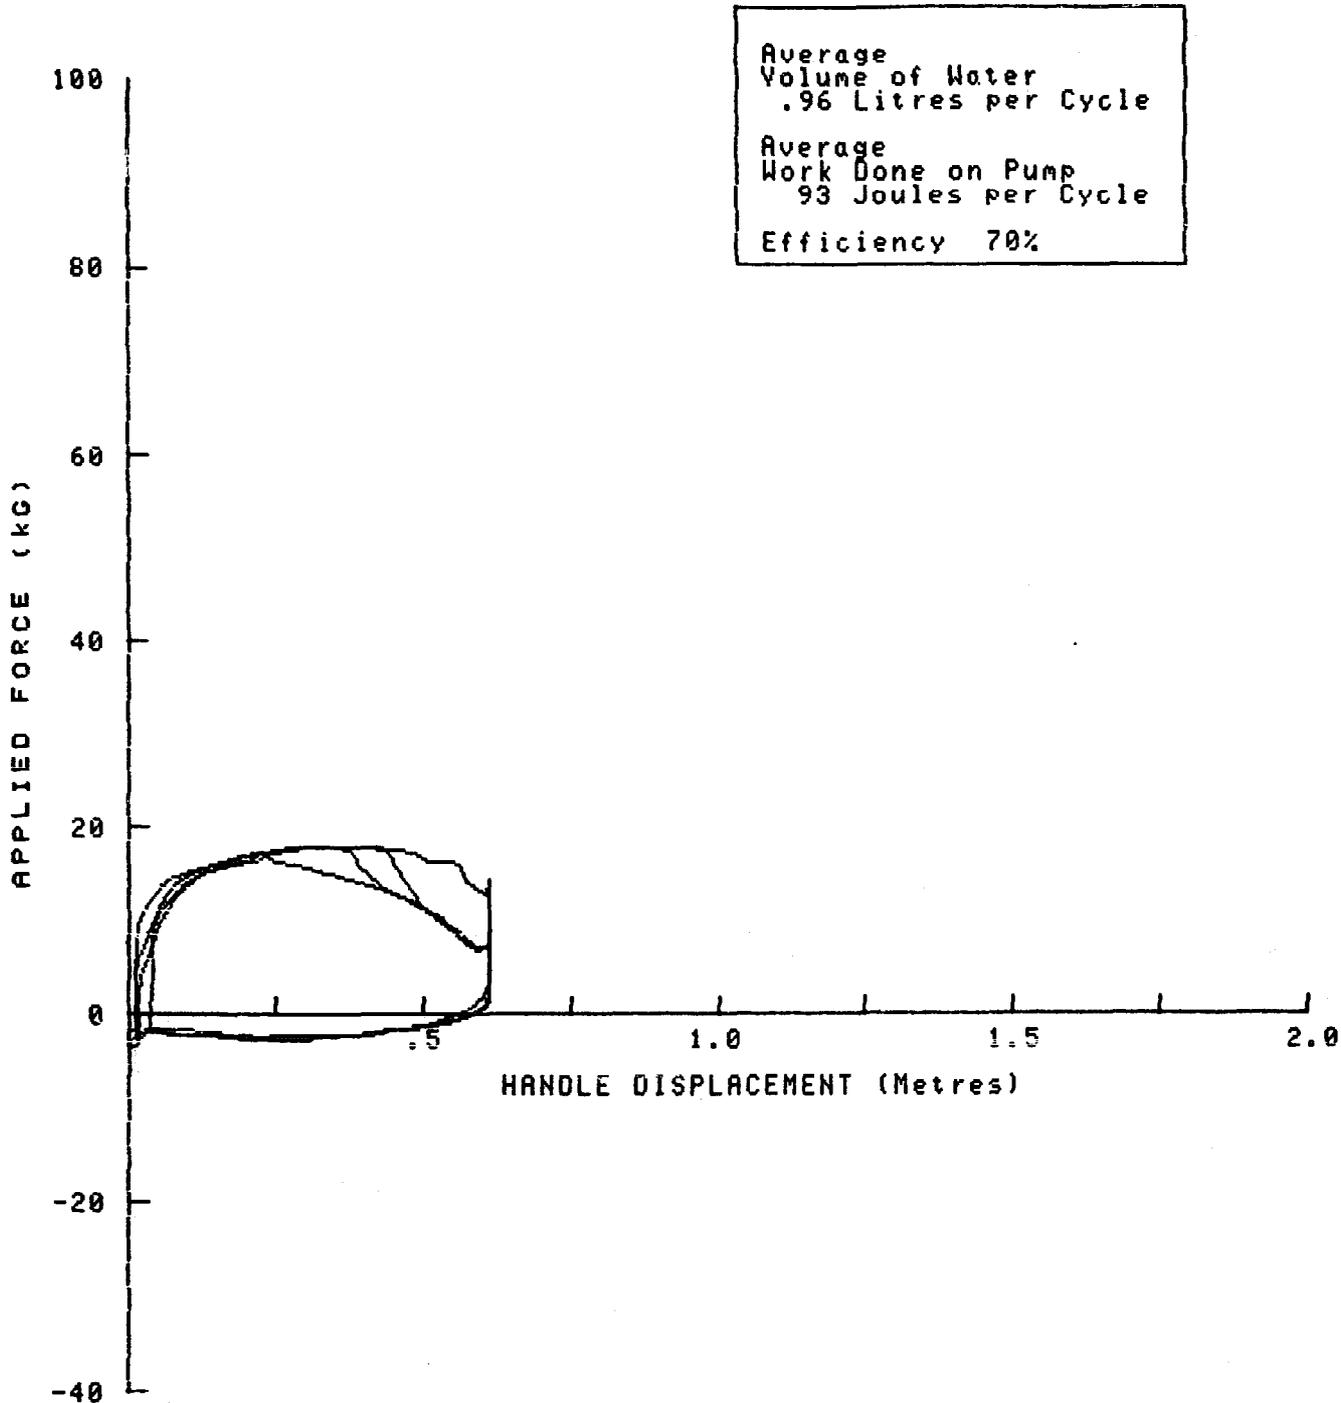
CODE L Bandung

The results before endurance testing suggest some irregularities in the performance of the plunger seal or valve.

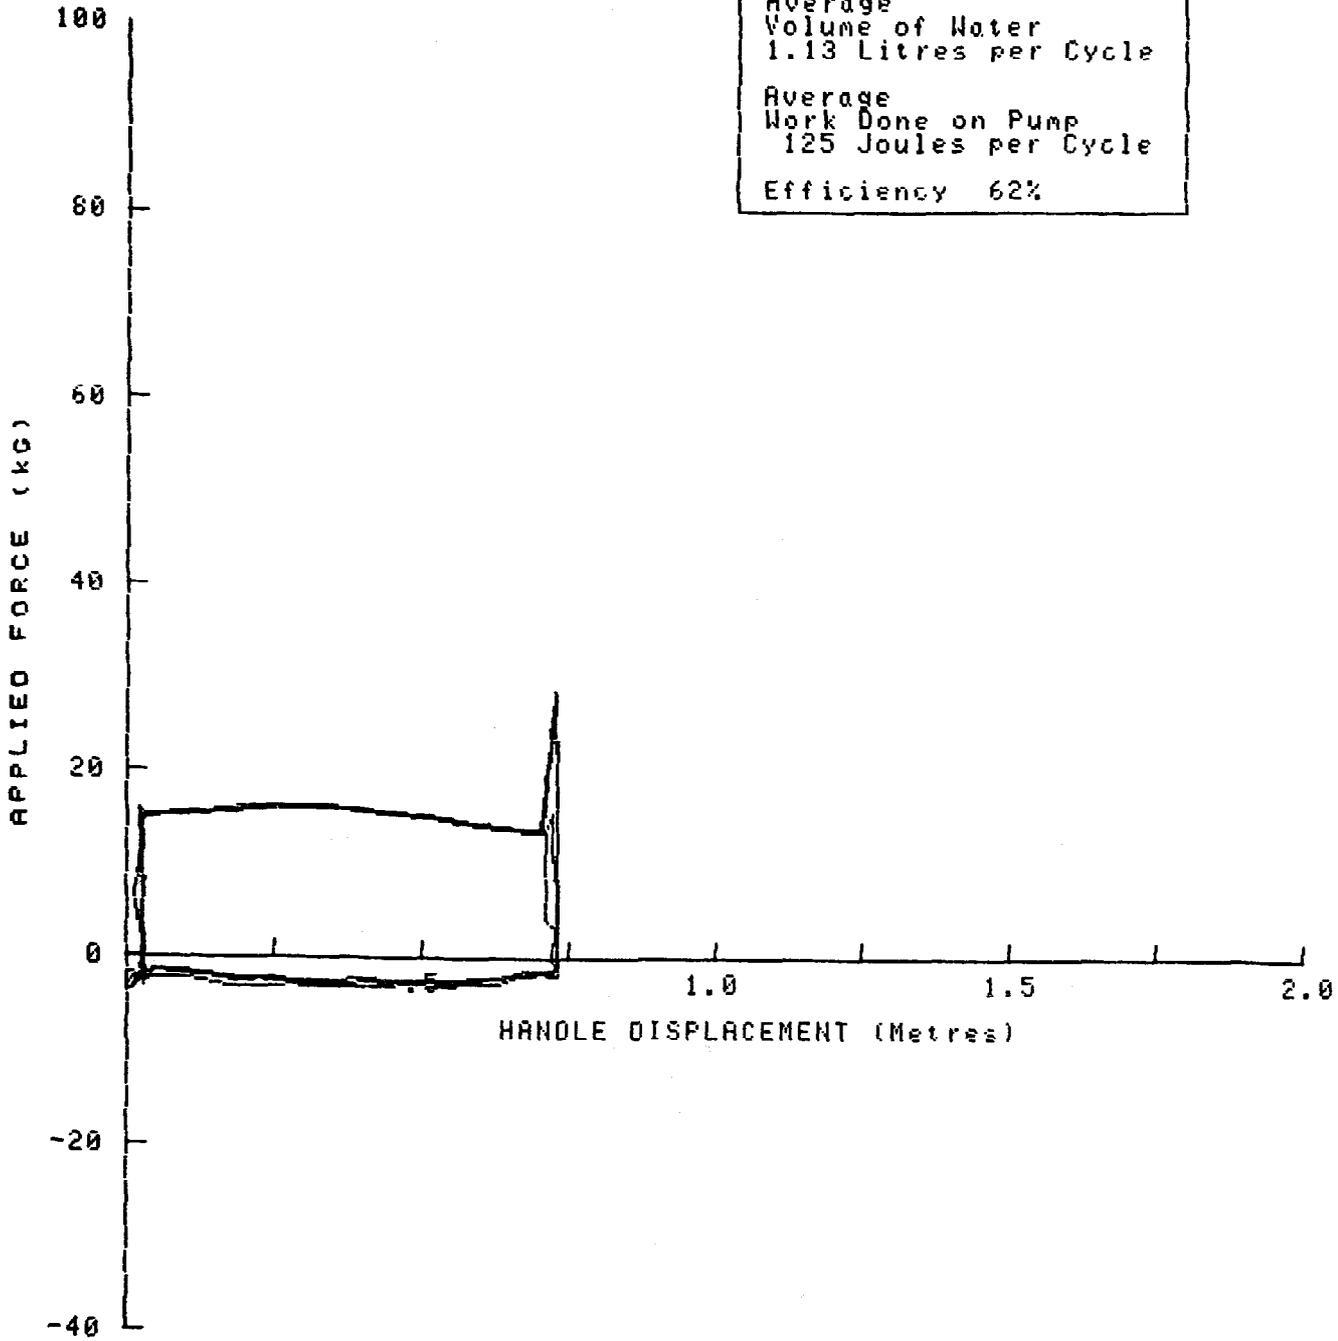
PUMP PERFORMANCE after endurance CODE L Bandung

No irregularities are indicated, suggesting that the plunger seal and valve were working satisfactorily during this test. Note that the plunger seal was replaced three times during the endurance test.

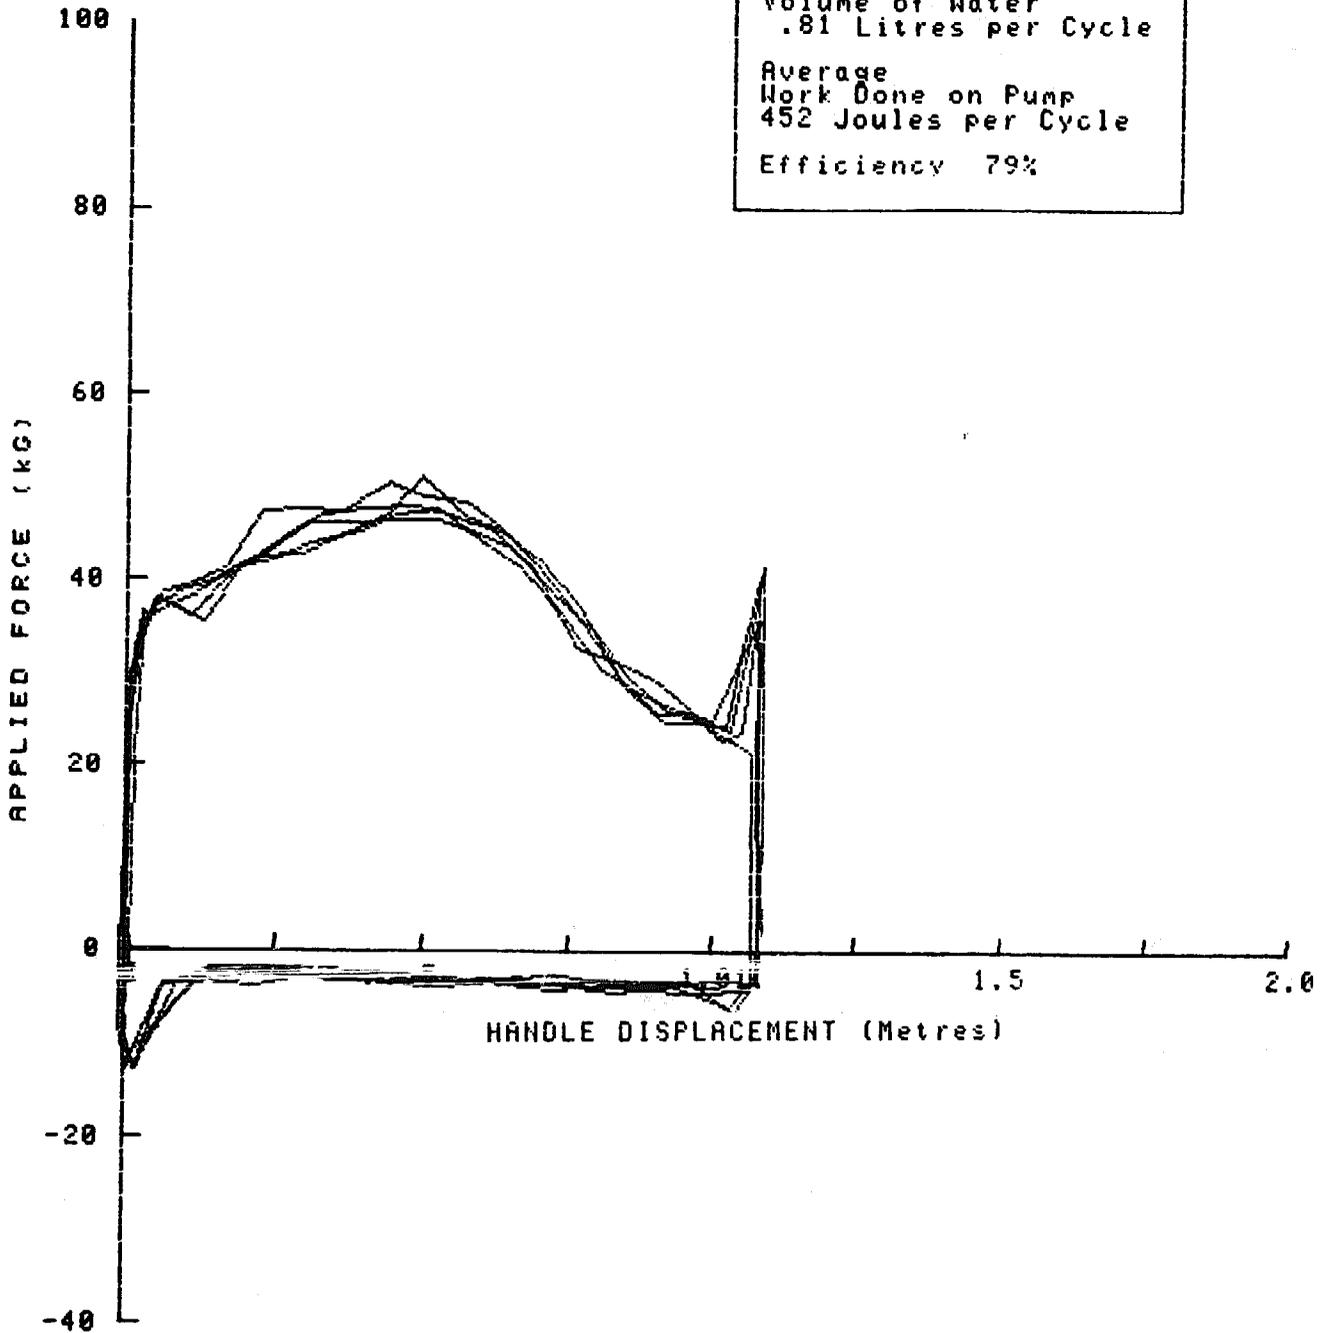
PUMP PERFORMANCE after ENDURANCE CODE M Sumber Banyu

The results before and after endurance should not be directly compared because the cylinder components were replaced during the endurance test.
